Dam Safety Branch

When replying, please refer to:  
**OVERLAND #1 DAM, DAMID: 400422**  
**Water Division 4, Water District 40**

**SUBJECT: Engineer's Inspection Report**

# ENGINEER'S INSPECTION REPORT

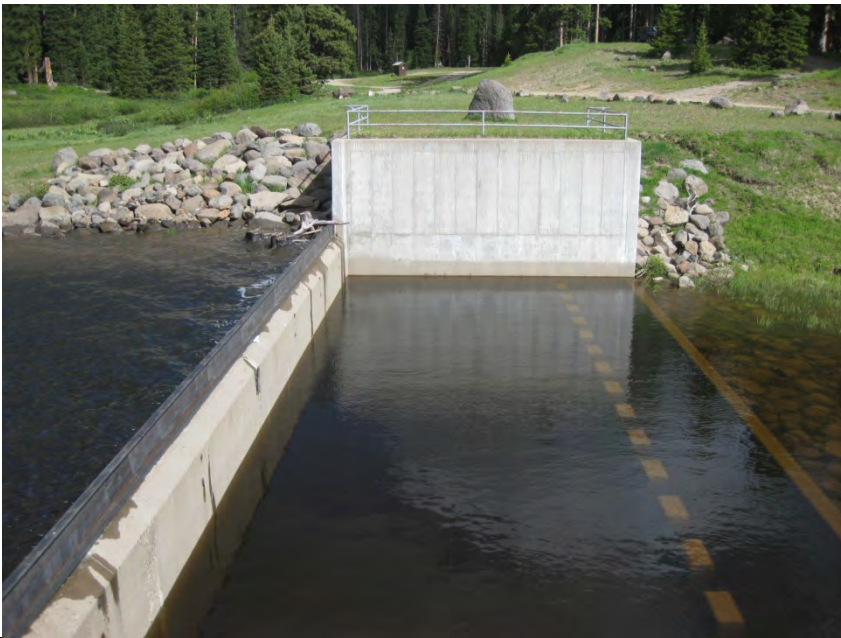
Looking across spillway stilling basin from right wingwall.

Spillway abutment  
drain outfall

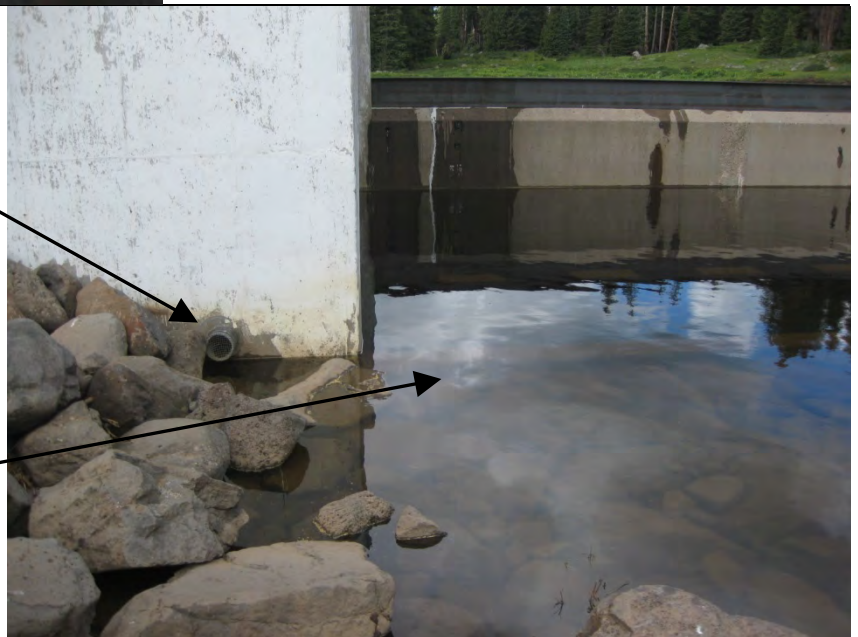
Looking upstream at right side of stilling basin

Approximate location of floor drain  
penetration through downstream sill  
(submerged with this pool level)

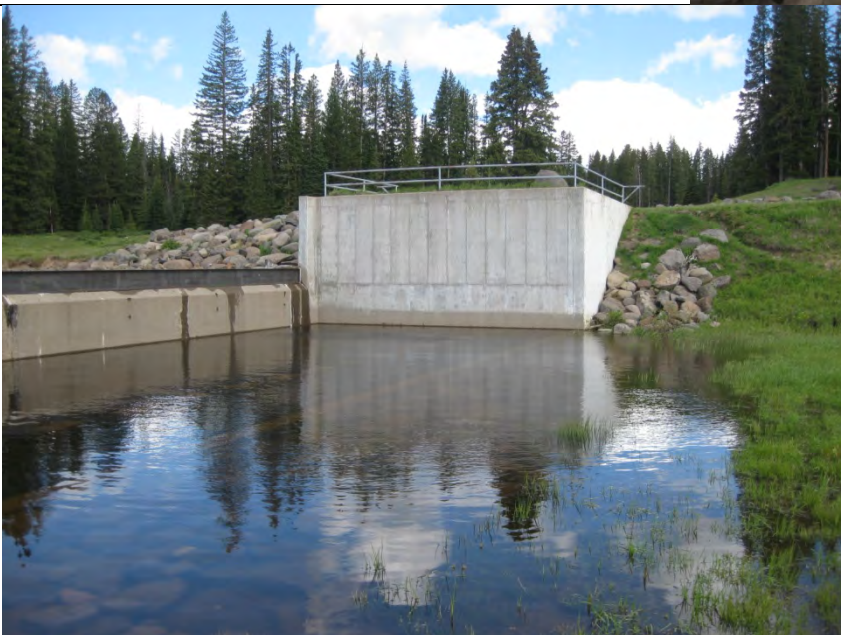
Water pooled in stilling basin and channel to approximately 1-foot over downstream sill in stilling basin. See drain discussion below.

(59) Based on the available head from the pool elevation in the stilling basin, flow from the floor drain would be expected to be significantly greater; possibly indicating the drain is partially obstructed.

Looking across pool in stilling basin with  
submerged downstream sill (assumed due to poor  
drainage of stilling basin through floor drain)

- ☐ (87) DEVELOP AND SUBMIT AN EMERGENCY ACTION PLAN: \_\_\_\_\_
- ☒ (88) OTHER **investigate repair or cleaning of poorly draining spillway stilling basin floor drain.**

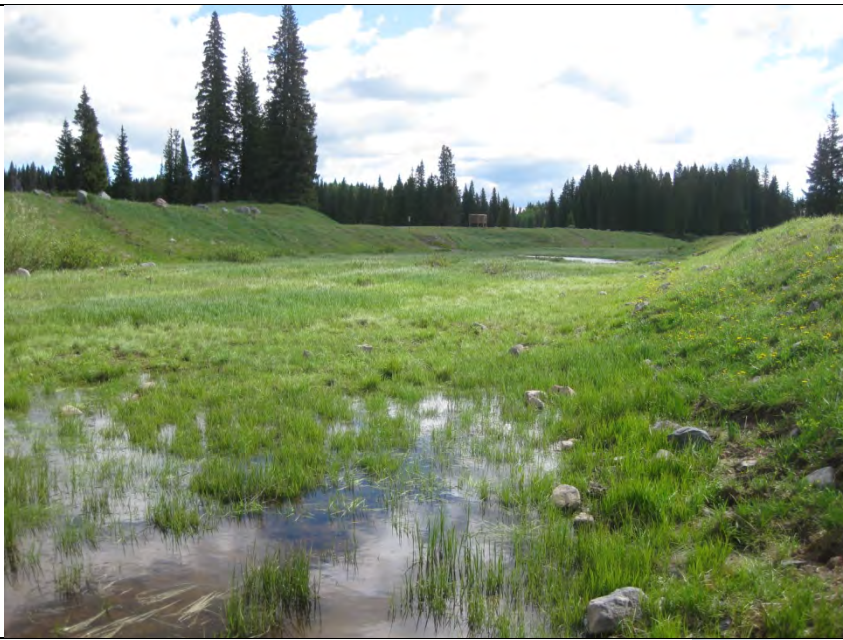
Looking downstream in spillway channel below stilling basin.

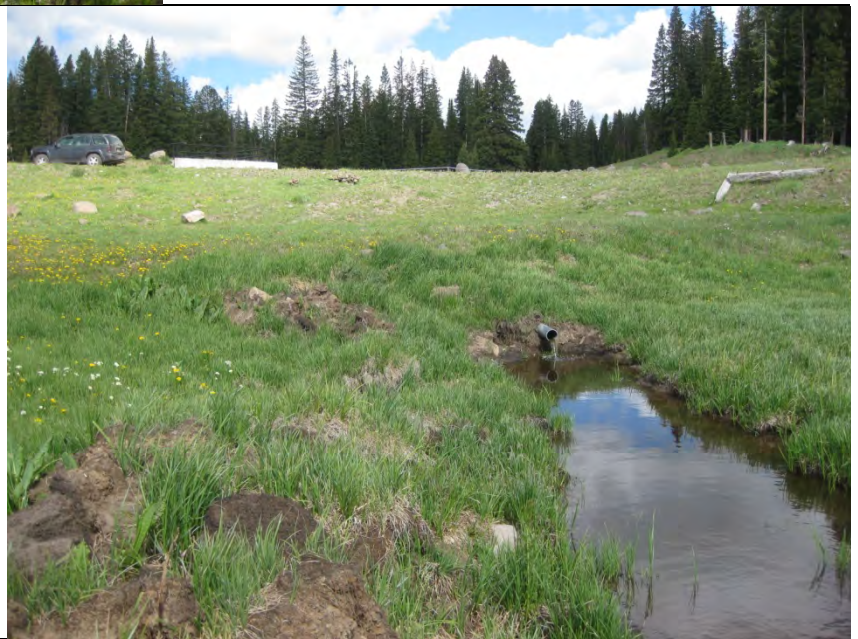
Per C-576C, the stilling basin has two drains; an underdrain system and a floor drain. Looking downstream, the left drain outfall (floor drain) was flowing 10-15 gpm during inspection and the right drain outfall (underdrain) had a small steady drip.

View of assumed outfall from spillway stilling basin floor drain

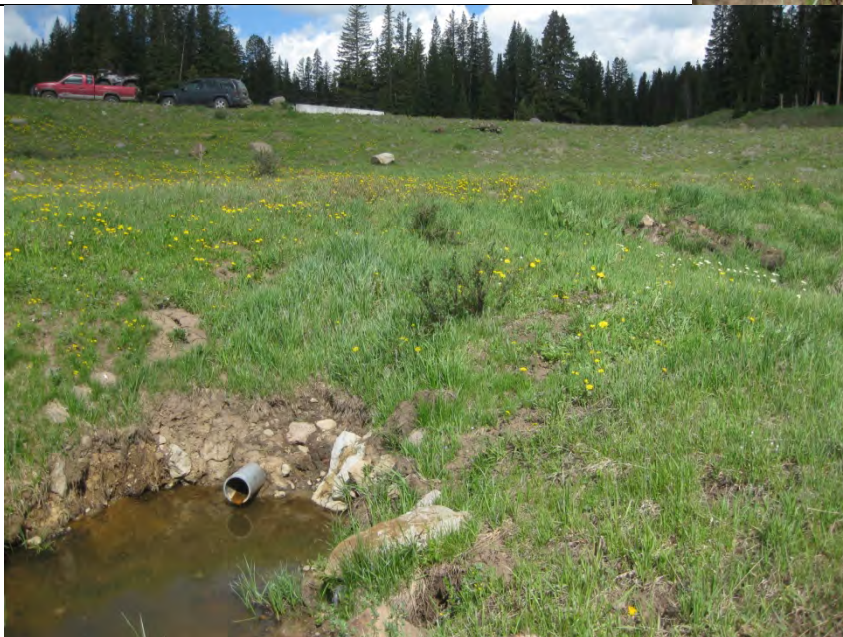
View of outfall from spillway stilling basin underdrain.

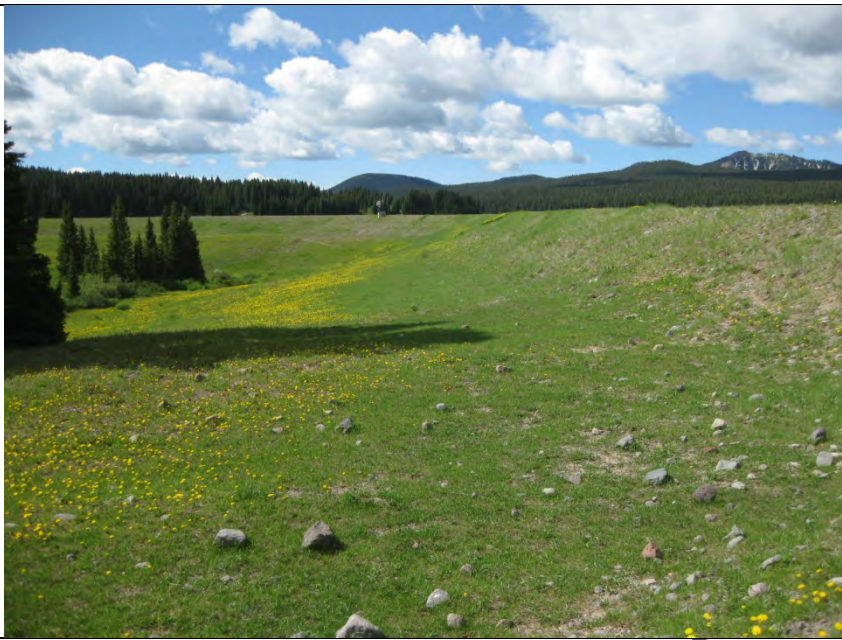
**Main Dam: Minor erosion locally along right half of dam. Overall appearance of slope is uniform and stable. No problems observed and slope rated in GOOD condition.**

Overall view of downstream slope of left portion of dam.

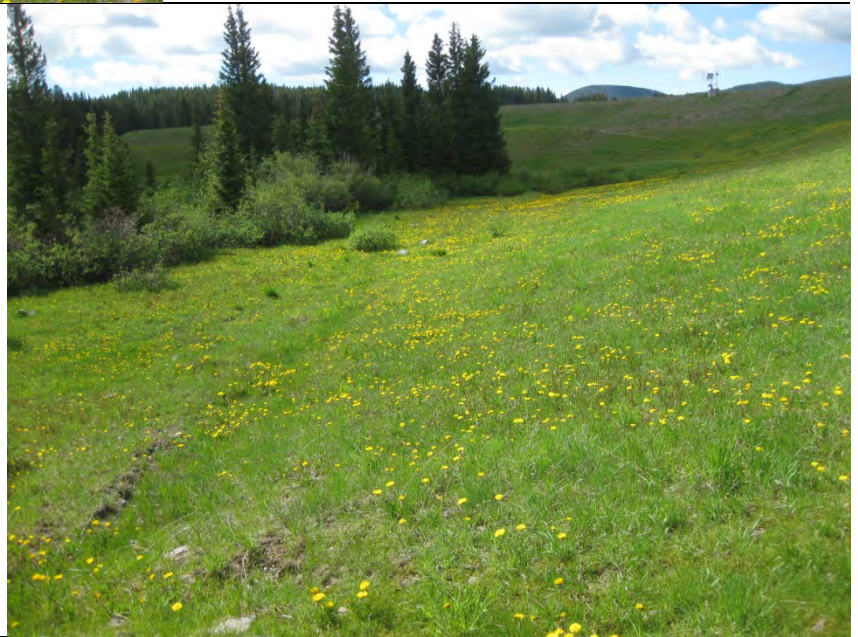
(34) Damp all along toe of 500+ feet long section at far left end of dam adjacent to spillway. Condition similar to past years observations at this reservoir level. Remainder of embankment toe observed dry. All toe drain outfalls found and observed, but not measured during inspection.

Toe along left portion of dam.

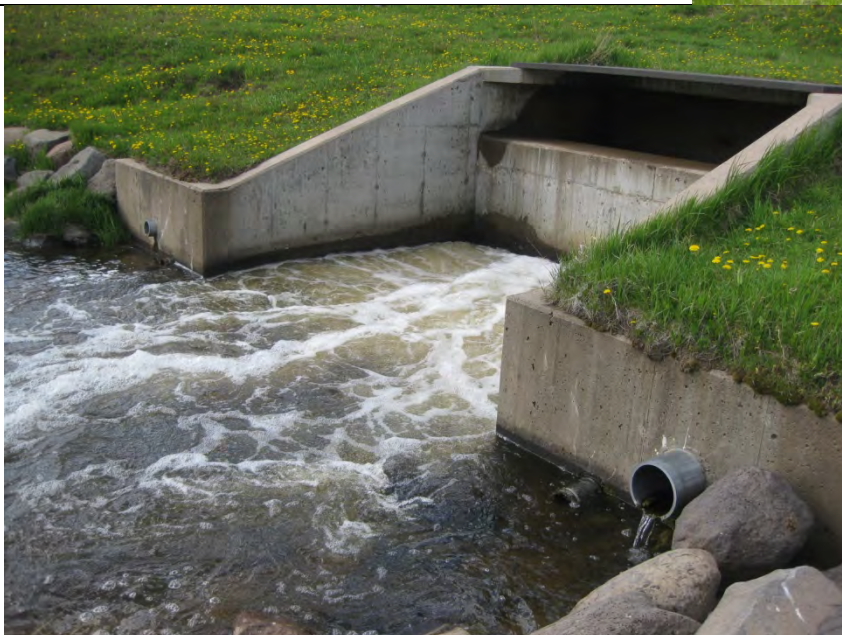
Outlet discharge structure with outfalls from left and right toe drains, conduit drain, and gate chamber drain.

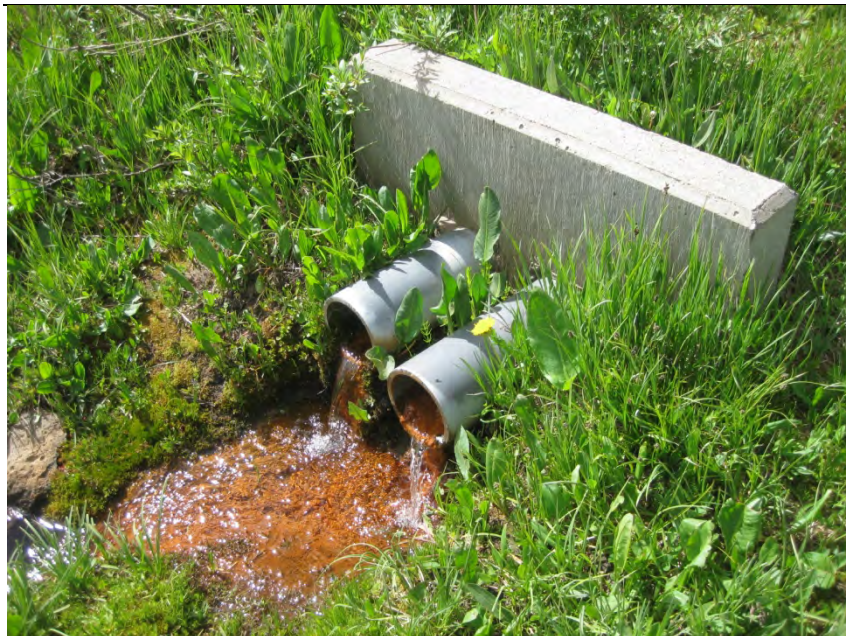
Drain B left and right outfalls: Running clear, no measurement (see photos)

Drain 'B' left and right drain outfalls.

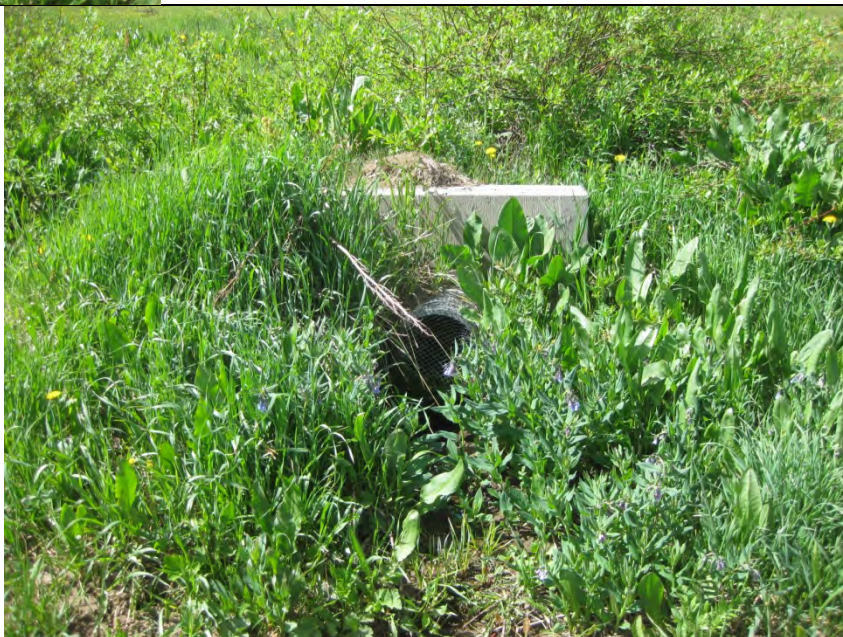
Drain A outfall: drip

Drain 'A' outfall.

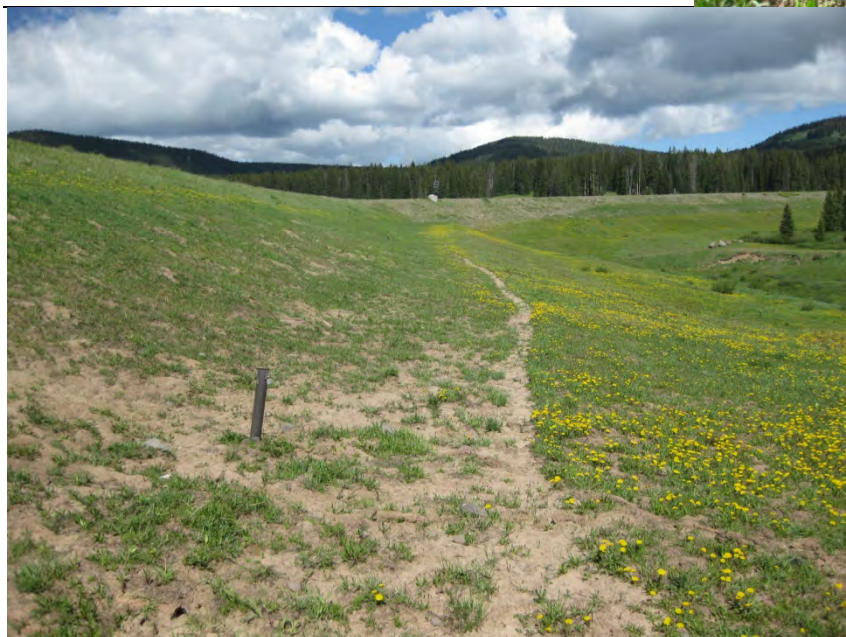
View along top of buttress on right portion of dam.

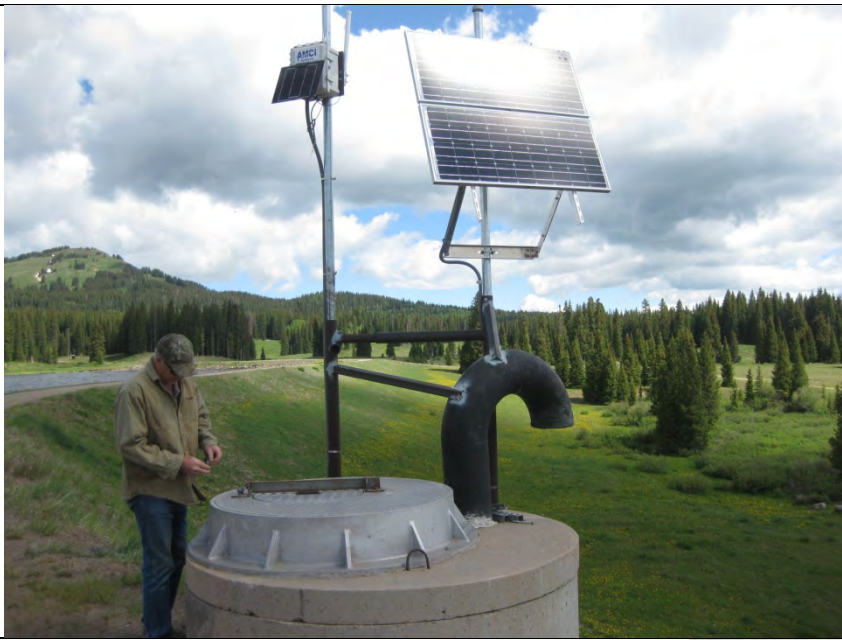
Outlet gate chamber access manhole located in dam crest at the maximum section.

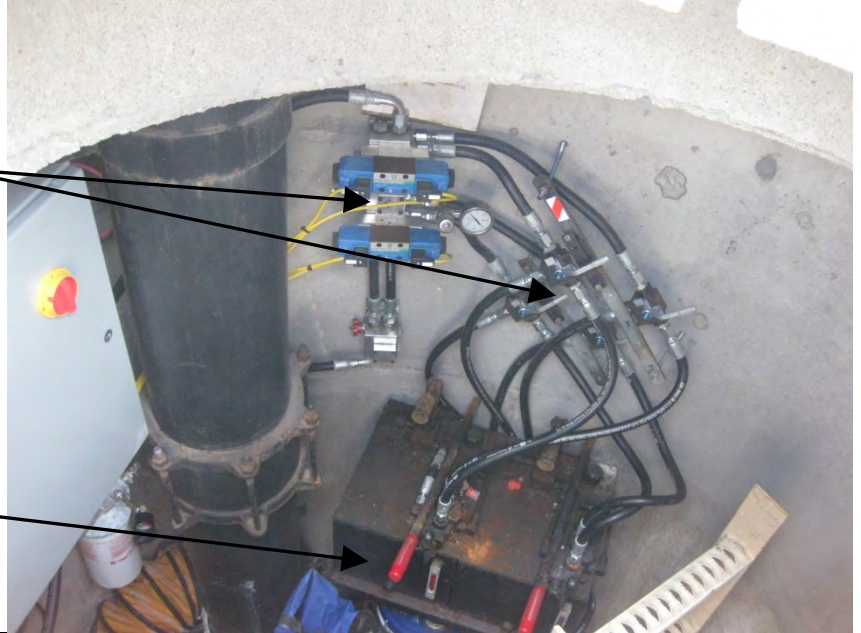
Automated gate operating system installed since last inspection, but not operational at current inspection (anticipated startup on 6/28/2014). Full manual operation with ability to visually monitor controls all retained.

Newly installed automated control components

View of hydraulically operated outlet gate controls with recent retrofit of automated controls.

Manual operation controls (fully functioning)

- ☐ (90) PREPARE PLANS AND SPECIFICATIONS FOR REHABILITATION OF THE DAM: \_\_\_\_\_
- ☒ (91) PREPARE AS-BUILT DRAWINGS OF: **automated outlet control system and submit to the Dam Safety Engineer (only if available from recent project)**

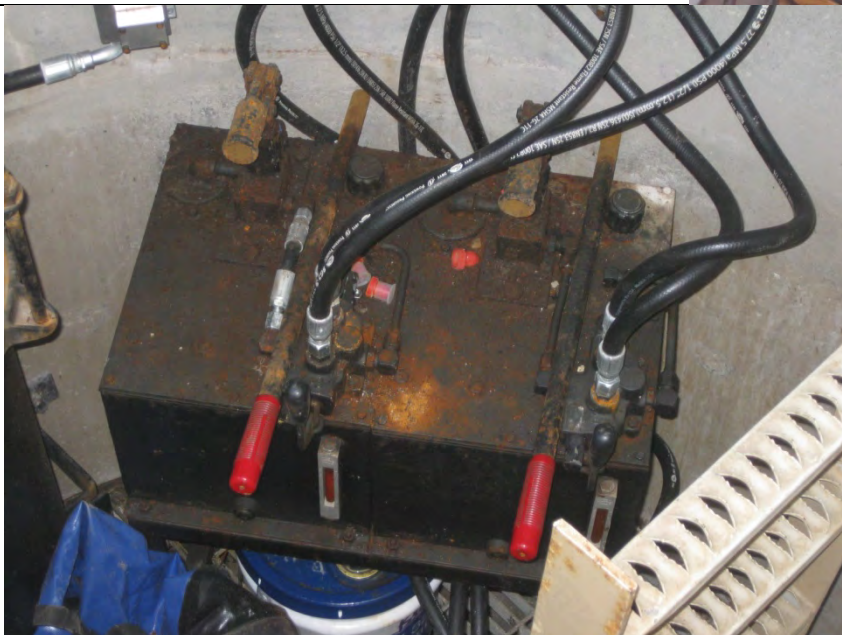
Close-up of manual hydraulically operated valve controls.

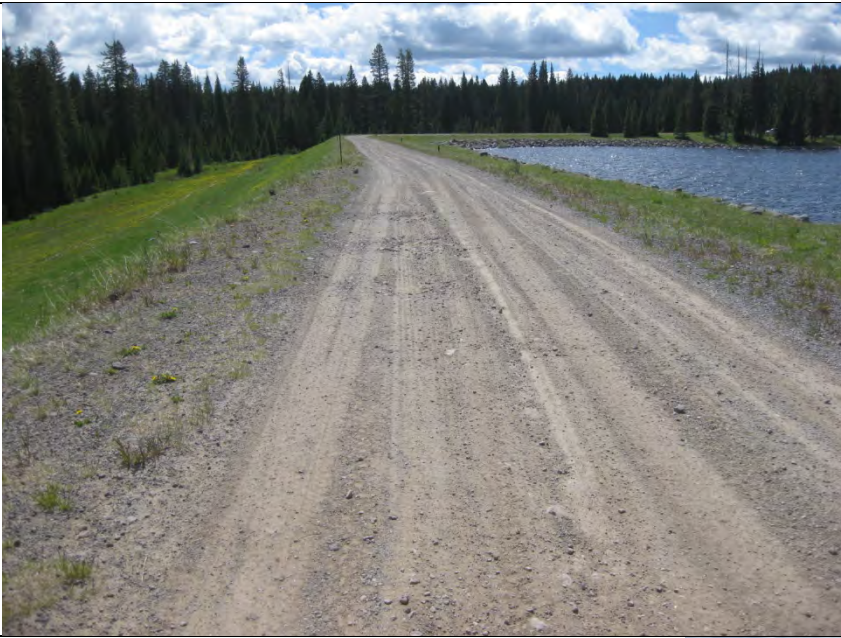
**Main Dam: Crest receives moderate vehicular traffic. (11) Few puddles observed on main portions of dam, but crest from left end near spillway to bend in dam at right end is considered in good condition. (11) Remaining approximately 750-ft of crest at far south (right) end of dam is deeply rutted with poor drainage.**

General view along dam crest of main dam.

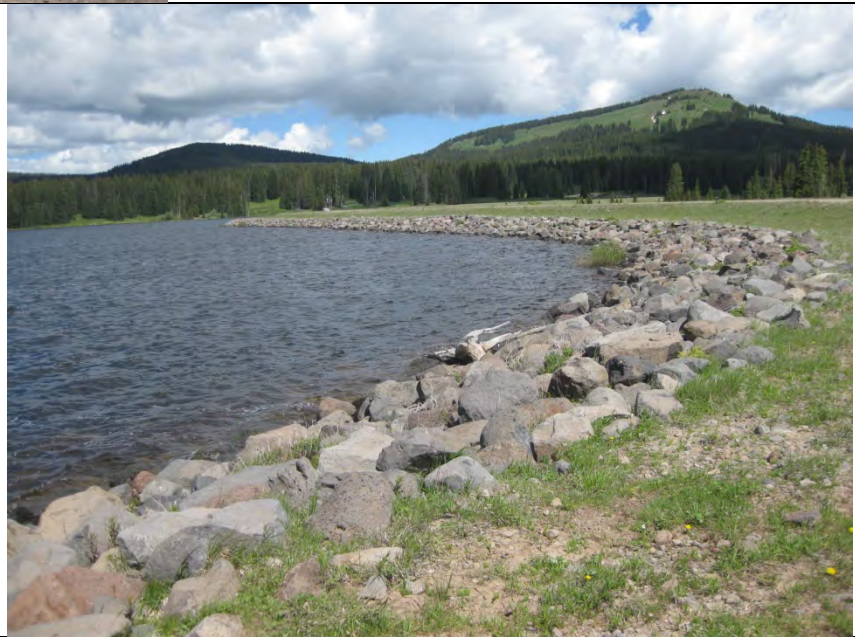
**Main Dam: Only freeboard portion of slope exposed at this reservoir level. Full riprap coverage along waterline. No wave erosion or slope instability observed.**

General view along upstream slope waterline.

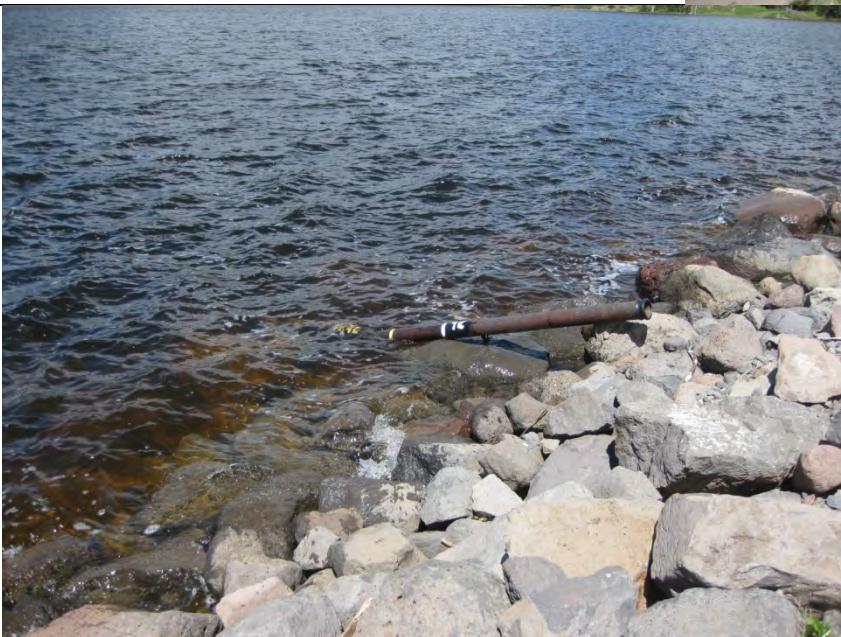
**(111) Gage rod recently painted.**

View of gage rod with newly painted numbers.  
Reservoir at gage height 41.5 ft during inspection.

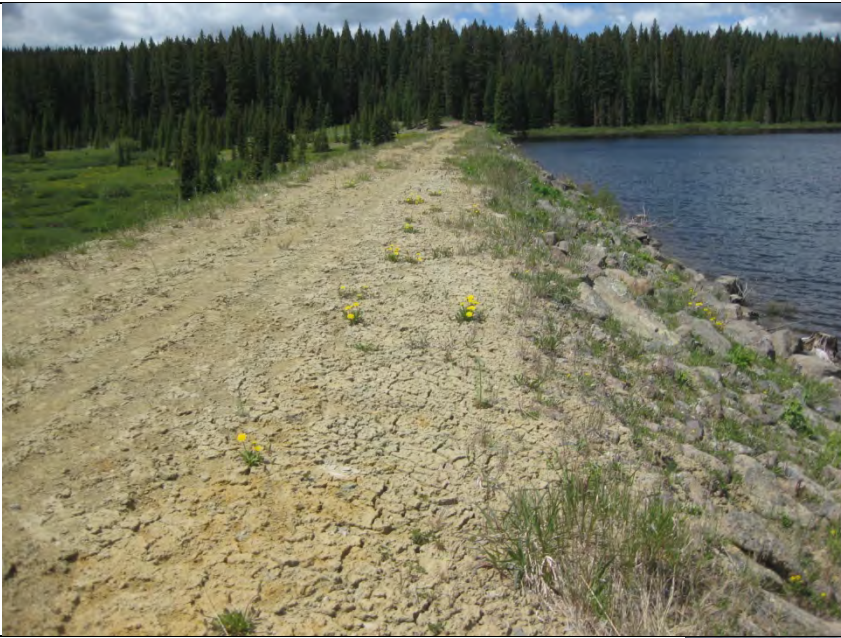
**Auxiliary Dam: (1) Sparse riprap coverage at this reservoir level. (2) Historic localized areas of wave erosion with scarps, but no indications of recent or active erosion. Slope appears stable.**

**(63)(64) Small trees and brush becoming locally dense on upstream slope of Auxiliary Dam.**  
**Investigate possible partial obstruction of spillway stilling basin floor drain.**

View along dam crest and upstream slope of Auxiliary dam.

- ☐ (80) PROVIDE ADDITIONAL RIPRAP: \_\_\_\_\_
- ☐ (81) LUBRICATE AND OPERATE OUTLET GATES THROUGH FULL CYCLE \_\_\_\_\_
- ☒ (82) CLEAR TREES AND/OR BRUSH FROM: **as needed from all embankment surfaces, particularly on upstream slope of Auxiliary dam.**

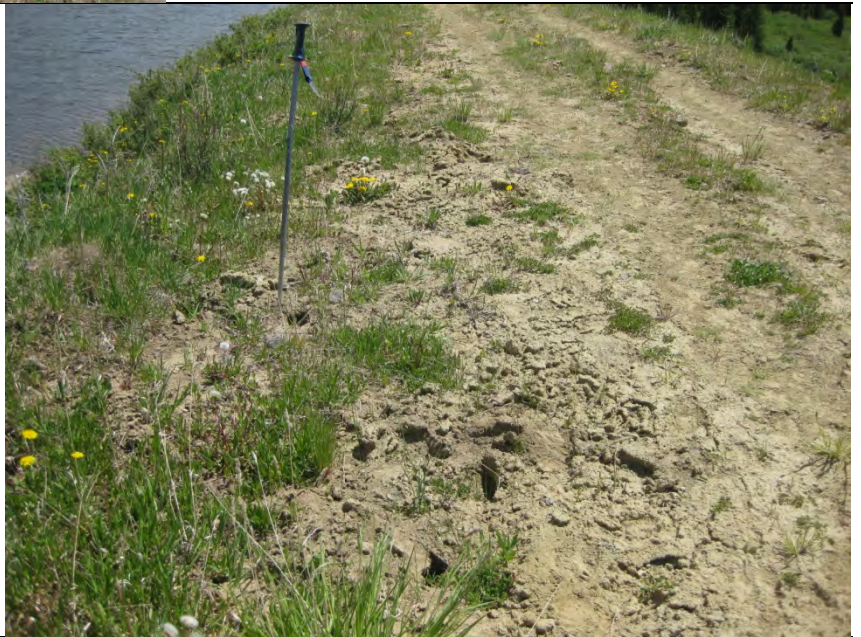
**Auxiliary Dam: Surface is rough with (18) varied drainage. Shallow desiccation cracking observed along full length. (19) Few small diameter rodent holes and collapsed tunnels observed, but all probed shallow.**

Close-up of typical rodent hole/collapsed tunnels on dam crest of Auxiliary dam.

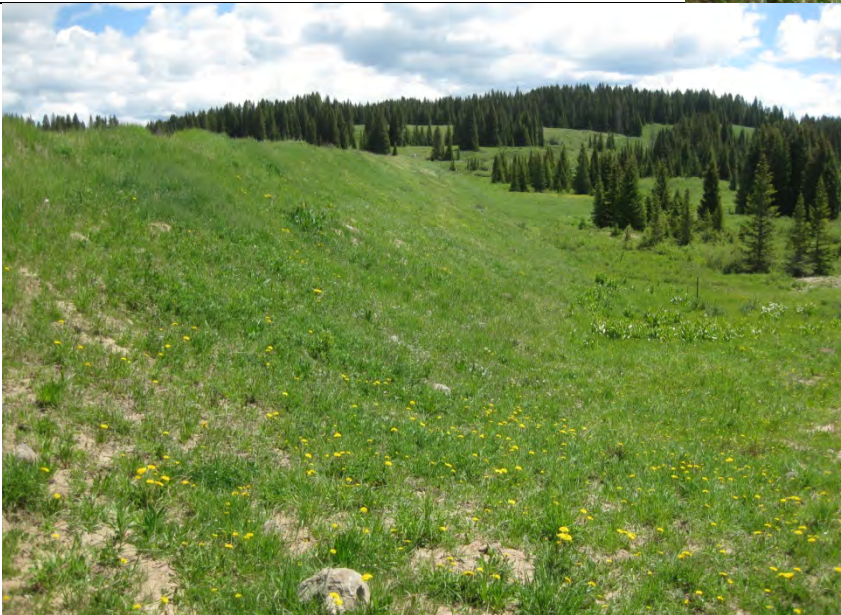
**Auxiliary Dam: Slope varies with (26) several areas of bulges and depressions. Generally good grass cover, except for localized bare area near top of slope at the maximum section. All conditions appear historic with no indication of slope displacement or movement. Conditions of slope are rated ACCEPTABLE.**

Overall view along downstream slope of Auxiliary dam.
