When replying, please refer to:  
**OVERLAND #1 DAM, DAMID 400422**  
Water Division 4, Water District 40

**SUBJECT:** Engineer's Inspection Report

# ENGINEER'S INSPECTION REPORT

DAM NAME: OVERLAND #1	T: 110S R: 0920W S: 23	COUNTY: DELTA	DATE OF INSPECTION: 8/7/2017
DAM ID: 400422 YRCompl: 1987	DAM HEIGHT(FT): 60.0	SPILLWAY WIDTH(FT): 75.0	PREVIOUS INSPECTION: 7/27/2016
CLASS: High hazard	DAM LENGTH(FT): 3200.0	SPILLWAY CAPACITY(CFS): 4367.0	NORMAL STORAGE (AF): 5828.0
DIV: 4 WD: 40	CRESTWIDTH(FT): 20.0	FREEBOARD (FT): 6.0	SURFACE AREA(AC): 252.0
EAP: 8/4/2012	CRESTELEV(FT): 9897.0	DRAINAGE AREA (AC.): 6200.0	OUTLET INSPECTED: 9/4/2009

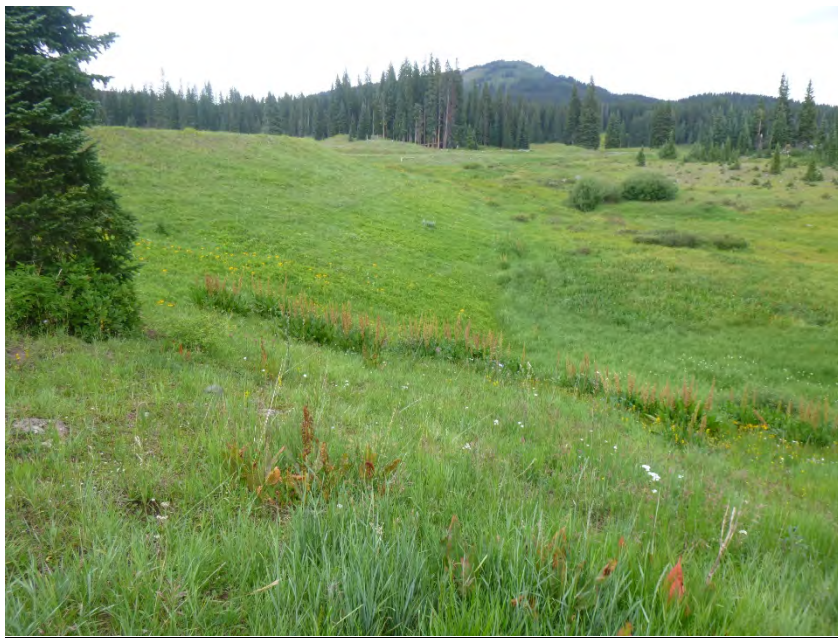
View along downstream slope of saddle dam between Main dam and Spillway.

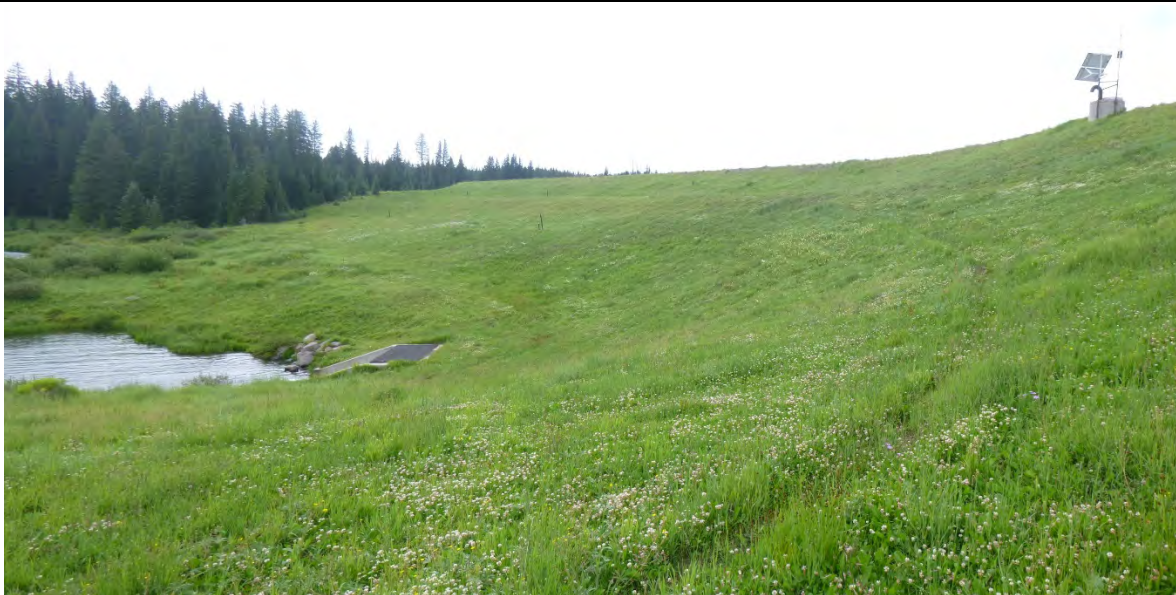
**(21) Clear evidence of livestock activity on the dam in the form of hoof damage and light but well established trails. No significant damage found. Slope appears stable and uniform.**

View along downstream slope of Main dam.

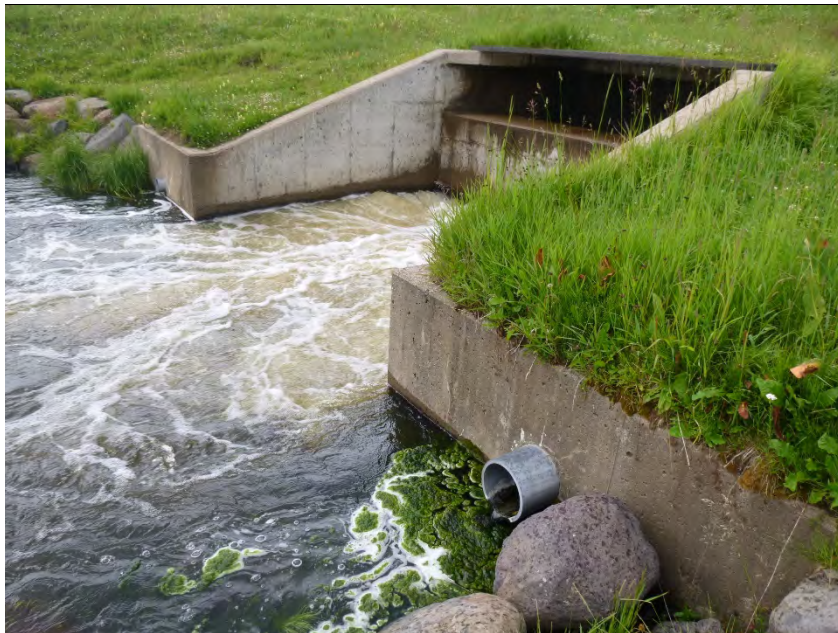
Downstream baffled outlet structure. Drain outfalls partially or fully submerged at this outlet discharge flow.

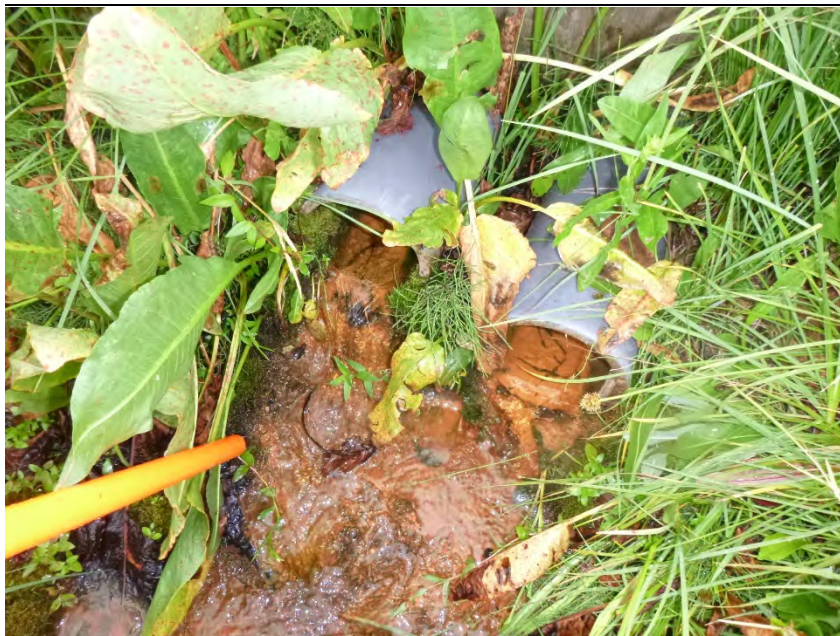
Toe Buttress drain outfalls (for Drain B, per C-576C).

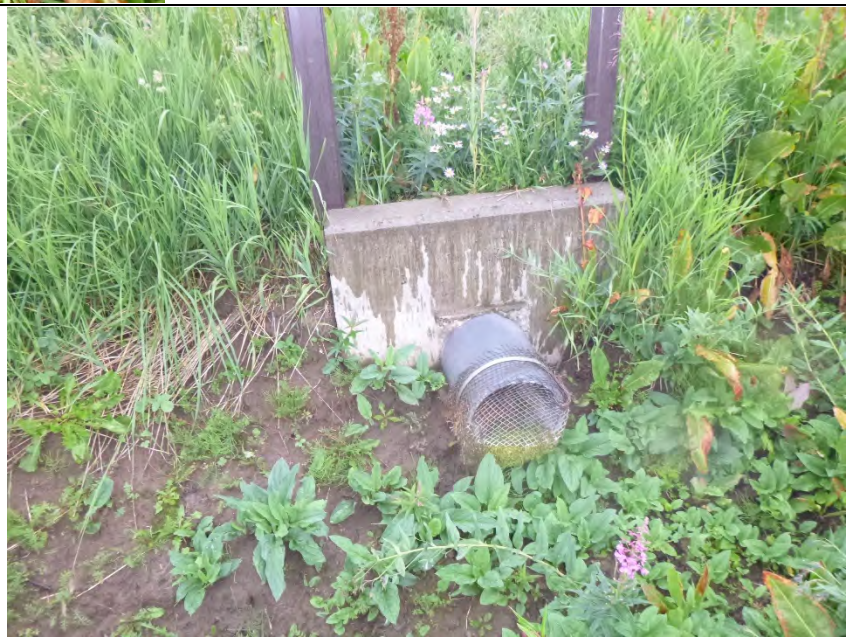
Buttress drain 'A' outfall.

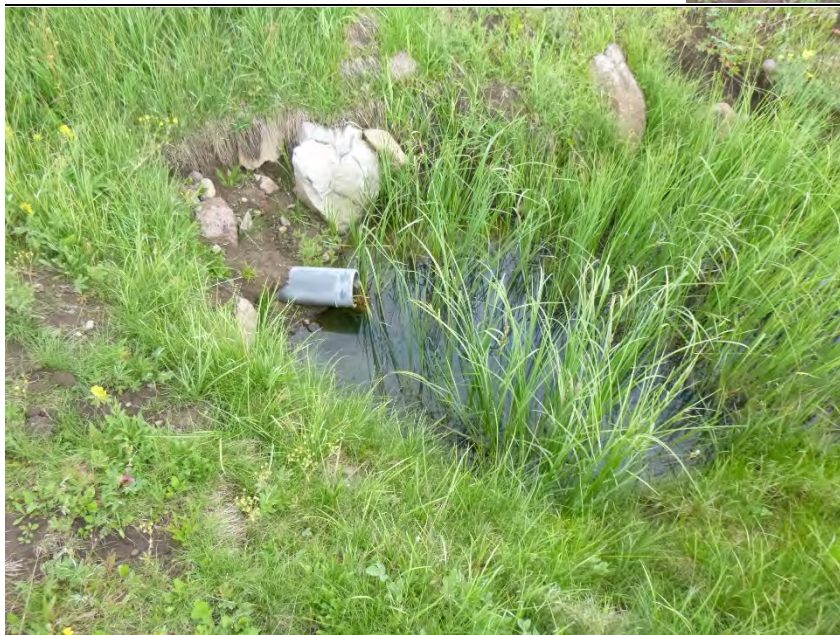
Outfall Spillway Structure Drain (per C-576C)

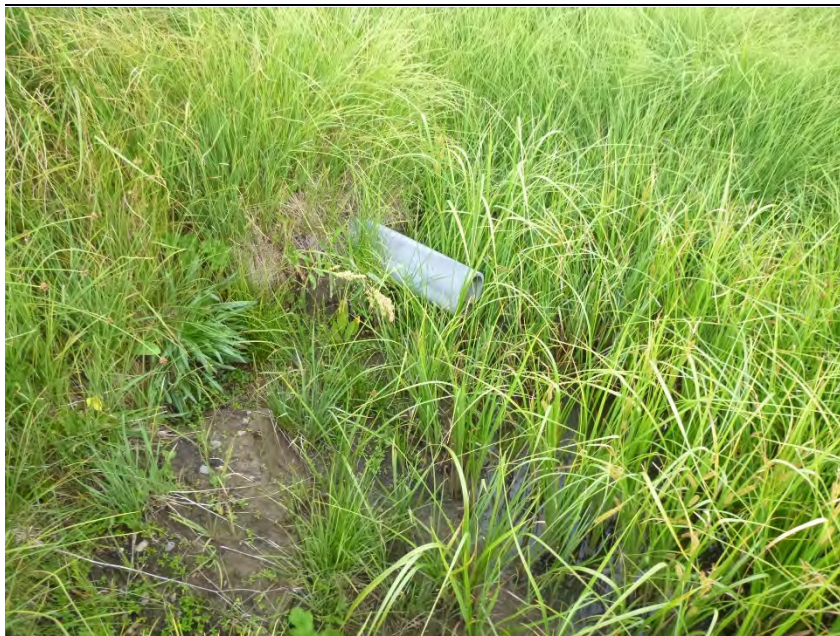
Outfall Spillway Underdrain (per C-576C)

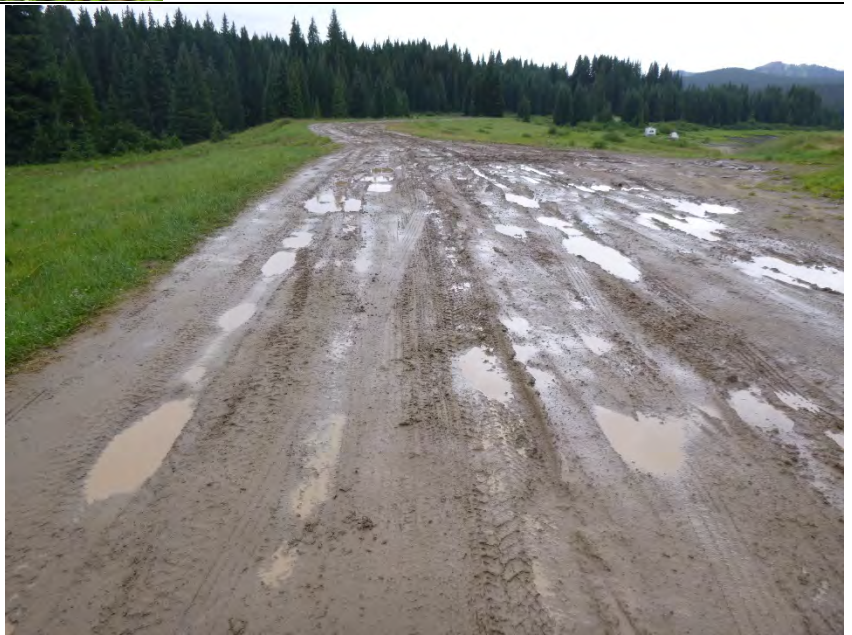
**Main Dam:** (11) Recent heavy rain revealed moderately-sized potholes on crest of main dam, particularly around the outlet controls manhole. Dam crest elevation, width, and alignment all appear uniform through main section of dam. However, (11) extensive rutting begins at right end of Main dam and extends along right wing dike of dam. Uncertain how elevation is affected along this portion. POOR rating for this section only.

Rutted, puddled, and muddy crest along far right end of dam.

**U.S. Forest Service contacted by Owner for grading of dam crest and import of material for rutted section along right wing dike of Main dam.**

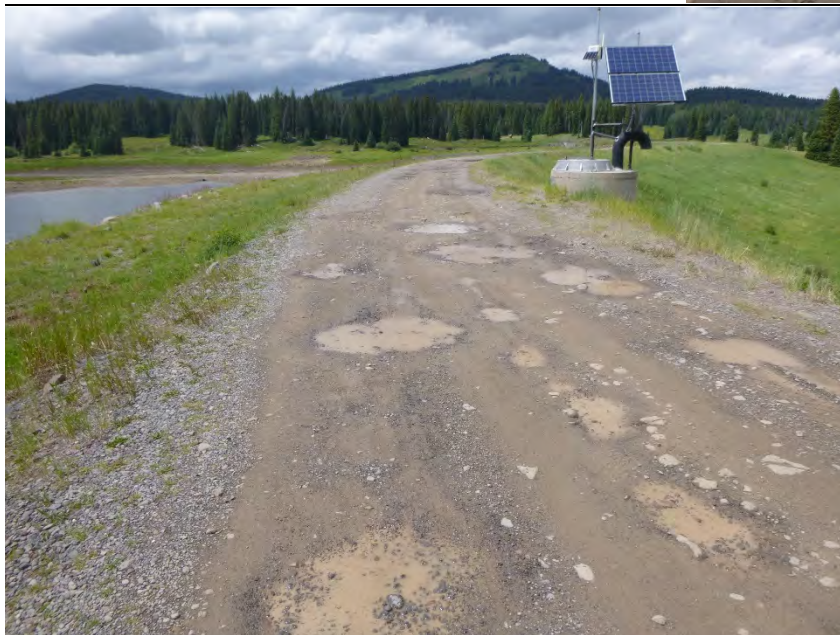
Puddles along dam crest near maximum section.

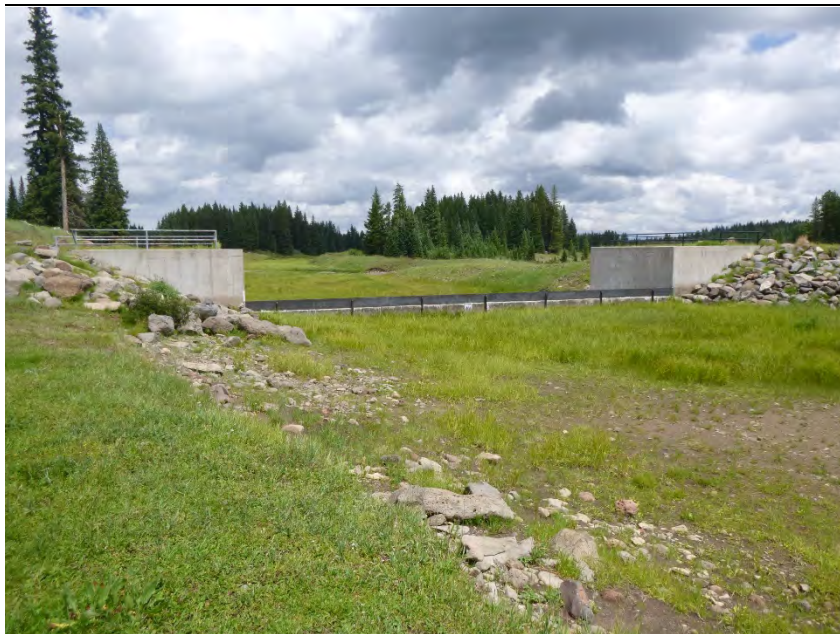
Looking downstream in spillway entrance channel.

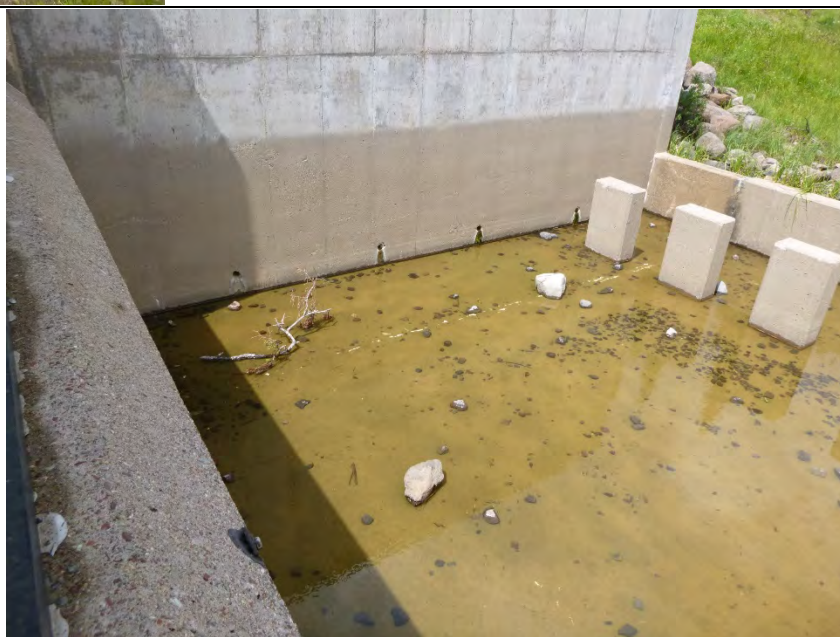
**Weep holes in spillway walls partially blocked with muck, but appear effective.**

Left spillway structure wall weep holes.

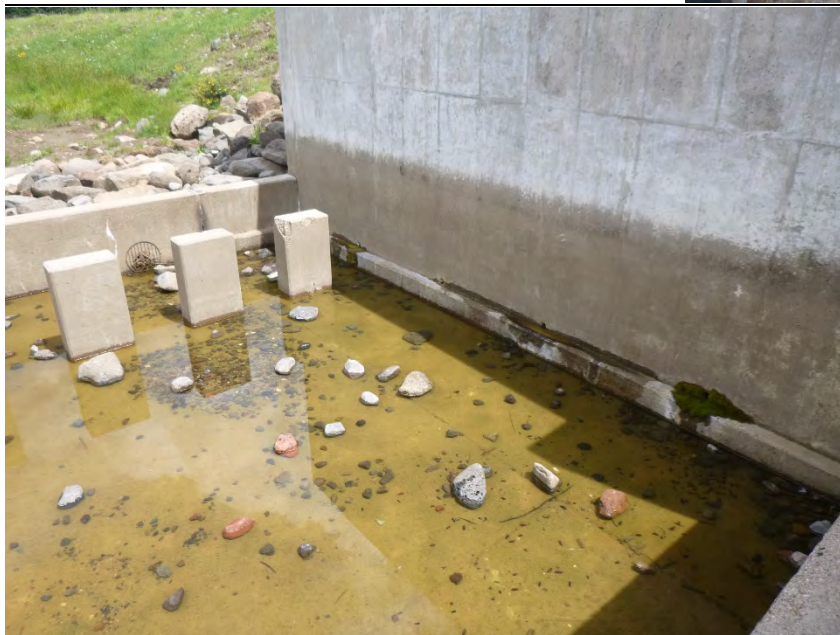
Right spillway structure wall weep holes.

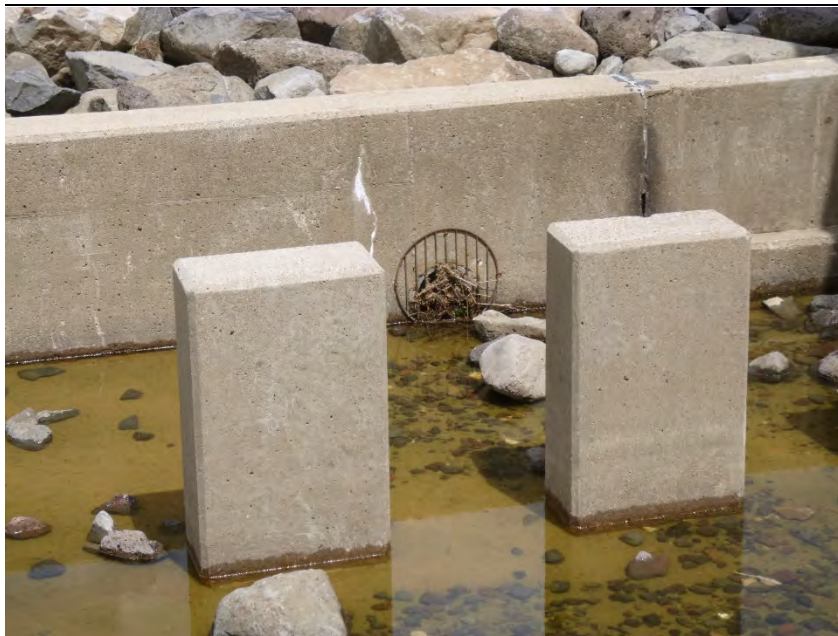
**Spillway floor drain recently excavated and cleaned of debris just beyond stilling basin. New grate installed at drain entrance.**

Spillway floor drain with new trashrack recently cleaned of debris.

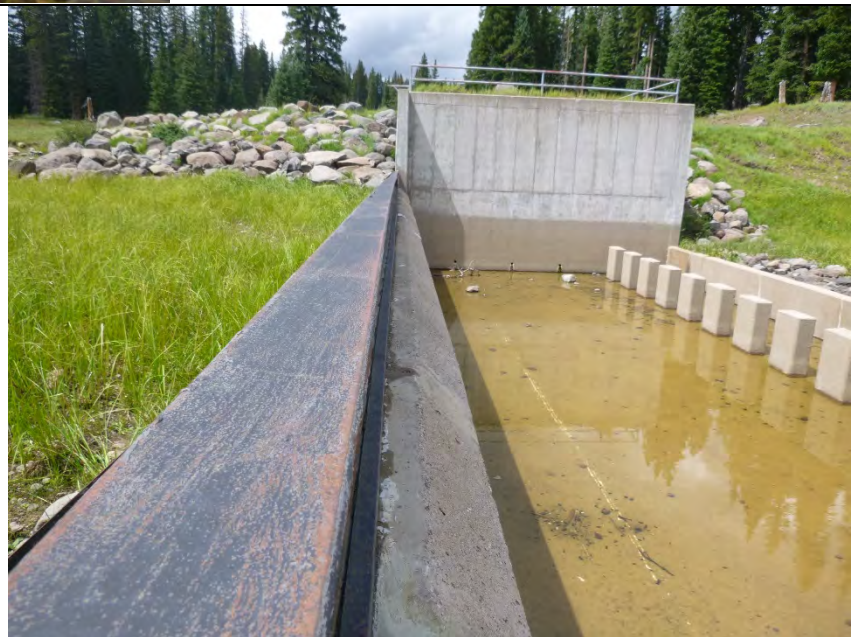
View along steel beam stop log at spillway crest.

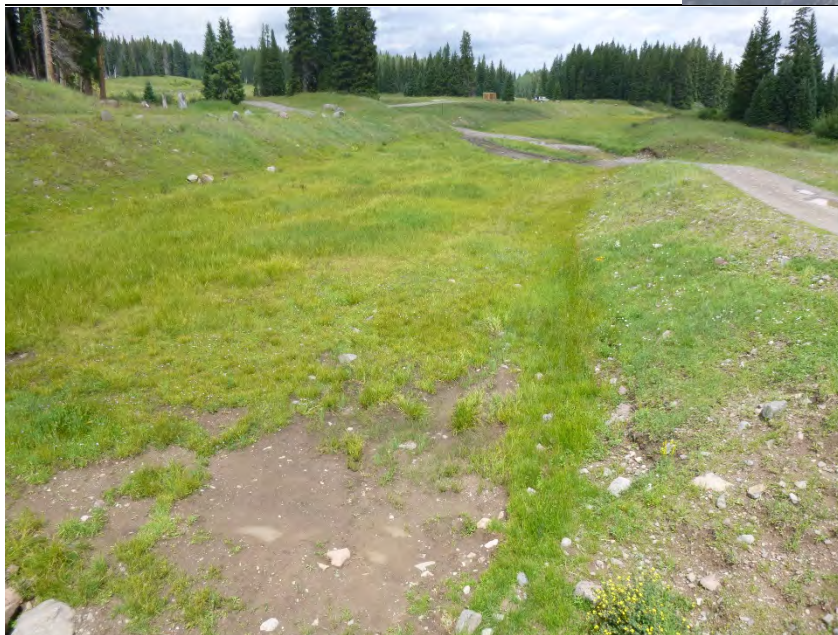
Looking downstream in spillway channel.

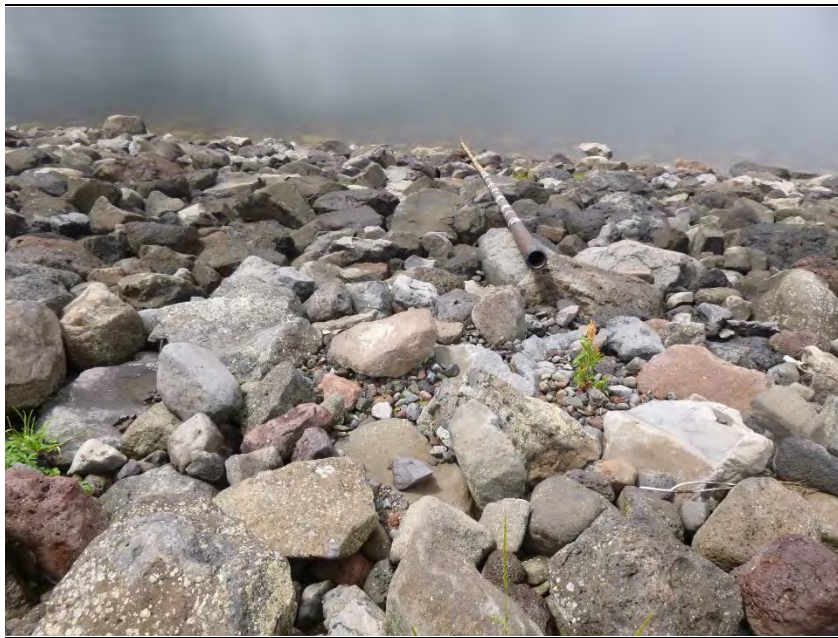
**(111) Gage rod reportedly broken at lower reservoir level. Continual problem due to ice damage and owner advised to consider more permanent ice-resistant alternative such as a concrete stem wall (Please note that plans and specifications for this structure must be approved by the State Engineer prior to construction).**

View along upstream slope riprap and gag rod.

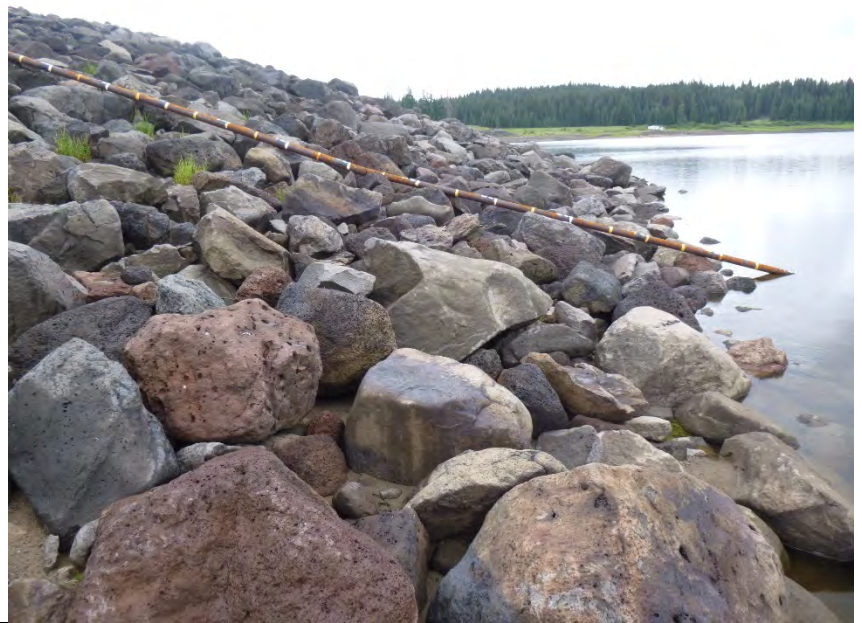
**Main Dam:** Generally complete riprap coverage along main portion of embankment. No signs of erosion, rock displacement, or instability. Slope and riprap have good uniform appearance.

Upstream slope at maximum section.

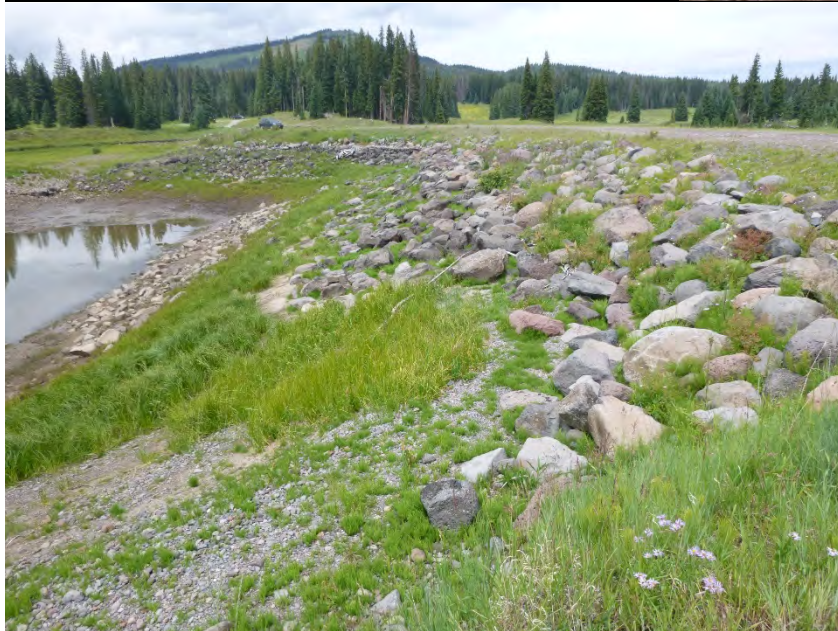
**(1) Riprap sparse between main portion and spillway. Small amount of high waterline erosion, but no signs of instability.**

Upstream slope left of maximum section  
between main dam and spillway.

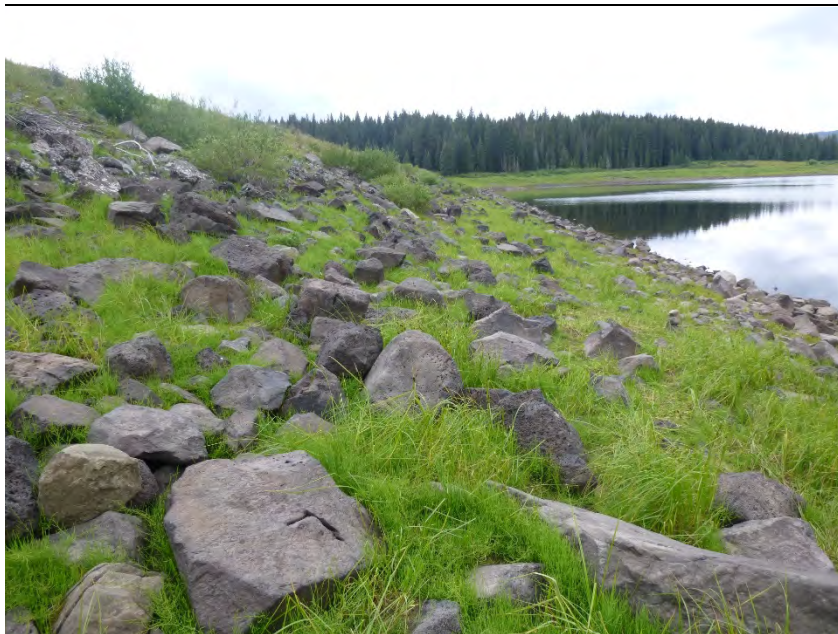
**(1) Riprap is sparsely placed and has gap-graded appearance (large boulders with small rock and voids). (2) However, wave erosion appears limited to high waterline where rock has been replaced periodically over the years to curb wave action. Condition acceptable and does not appear to have worsened in recent years. Sparse rock below approximately mid-height with slight beaching periodically. Overall slope is judged acceptable.**

Typical view along upstream slope of Auxiliary Dam.

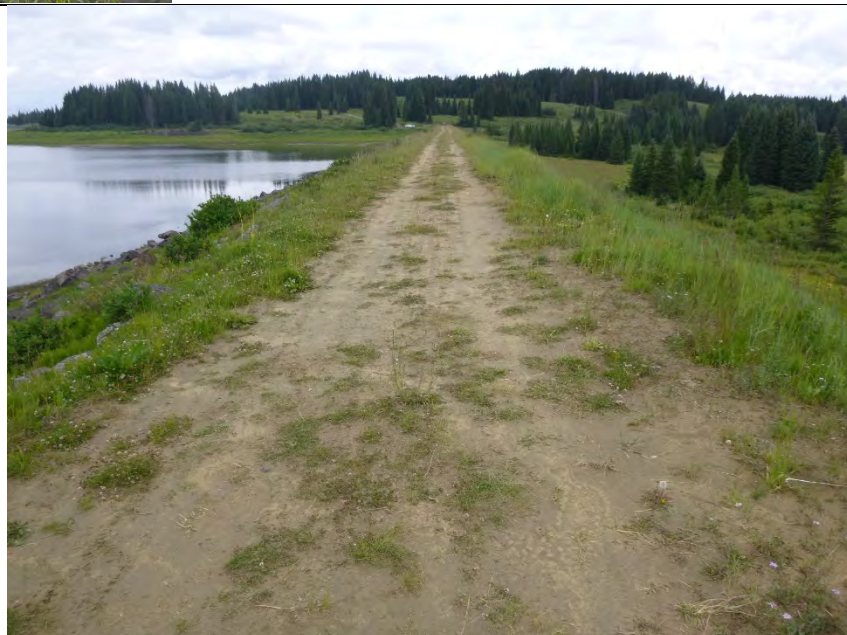
**Gate open during inspection with clear evidence of recent vehicular traffic. No apparent damage at this time, but closure of access has proven successful in the past to prevent rutting and damage to crest. Owner is encouraged to lock gate and prevent access.**

Typical view along dam crest of Auxiliary dam.

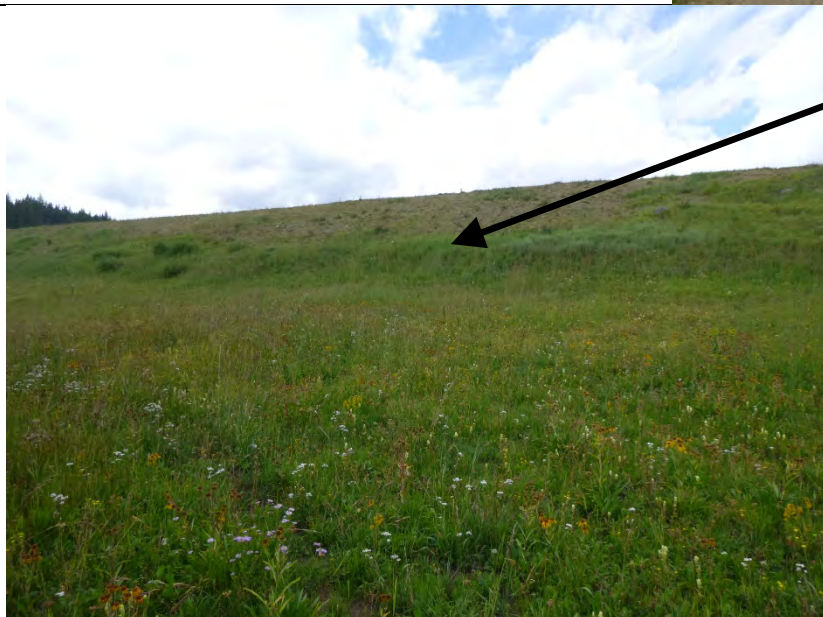
**Historic line of bulges along downstream slope at approximately 1/3 height. Otherwise, slope is uniform. Vegetation varies from uniform grass coverage along lower half to areas of bare ground along upper half. Uncertain of reason, but does not appear to be a slope stability or safety concern at this time.**

Historic line of bulge and change in vegetation along right portion of downstream slope.
