When replying, please refer to:  
**OVERLAND #1 DAM, DAMID: 400422**  
**Water Division 4, Water District 40**

**SUBJECT:** Engineer's Inspection Report

# ENGINEER'S INSPECTION REPORT

DAM NAME: OVERLAND #1	T: 110S R: 0920W S: 23	COUNTY: DELTA	DATE OF INSPECTION: 9/16/2015
DAM ID: 400422 YRCompl: 1987	DAM HEIGHT(FT): 60.0	SPILLWAY WIDTH(FT): 75.0	PREVIOUS INSPECTION: 6/27/2014
CLASS: High hazard	DAM LENGTH(FT): 3200.0	SPILLWAY CAPACITY(CFS): 4367.0	NORMAL STORAGE (AF): 5828.0
DIV: 4 WD: 40	CRESTWIDTH(FT): 20.0	FREEBOARD (FT): 6.0	SURFACE AREA(AC): 252.0
EAP: 8/4/2012	CRESTELEV(FT): 9897.0	DRAINAGE AREA (AC.): 6200.0	OUTLET INSPECTED: 9/4/2009

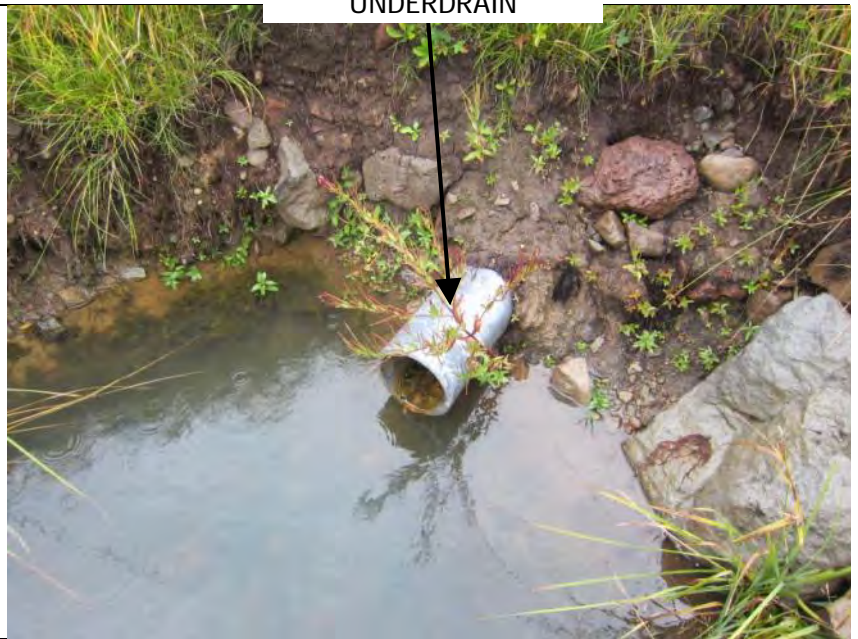
Spillway Stilling Basin  
UNDERDRAIN

**Right drain (stilling basin underdrain) running steady trickle flow.**

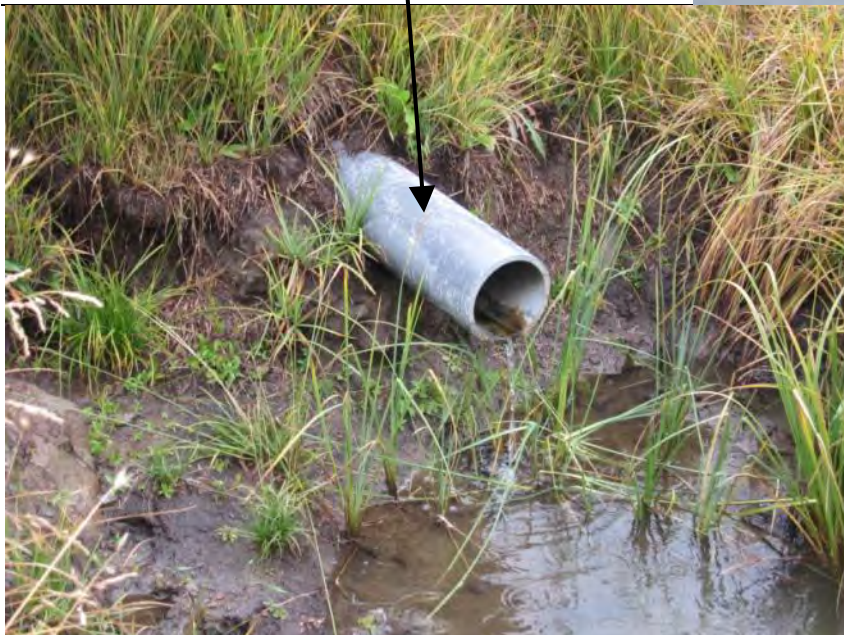
Spillway Stilling Basin  
FLOOR DRAIN

**Spillway drains: Left drain outfall as looking downstream (floor drain) running < 1 gpm.**

**(59) Six plus inches of standing water in stilling basin. Water level pooled above invert of floor drain indicating drain is possibly plugged.**

- ☐ (87) DEVELOP AND SUBMIT AN EMERGENCY ACTION PLAN: \_\_\_\_\_
- ☒ (88) OTHER repair gage rod broken section.
- ☒ (89) OTHER Investigate cleaning of all stilling basin wall weep drains. Investigate condition of floor drain and inability to fully drain stilling basin.

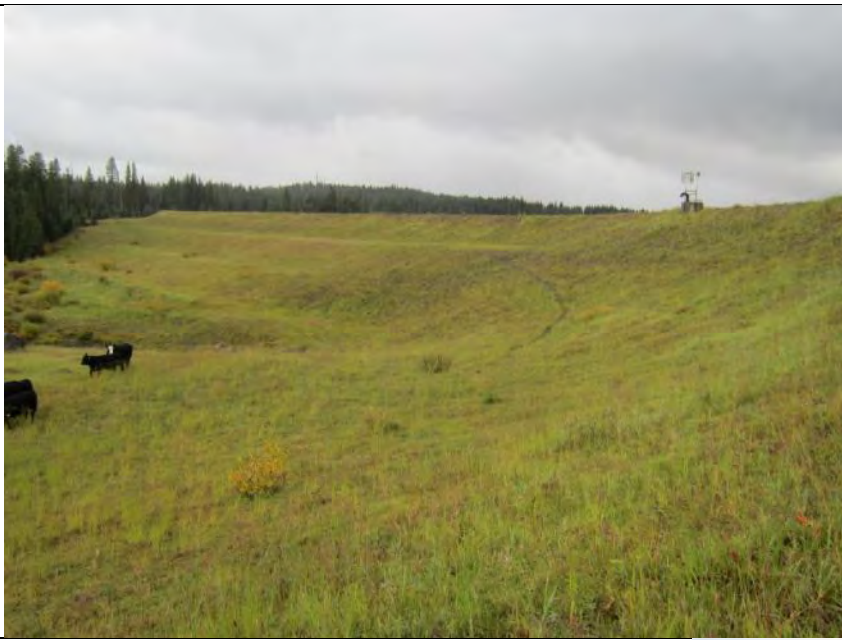
**Main Dam: Few areas of (22) drainage erosion and (21) livestock damage along slope as noted in past years inspection. However, majority of damage appears localized and overall slope appears stable. Slope varies by design and appears uniform. No stability problems observed.**

Overall view of dam and downstream slope from left of maximum section.

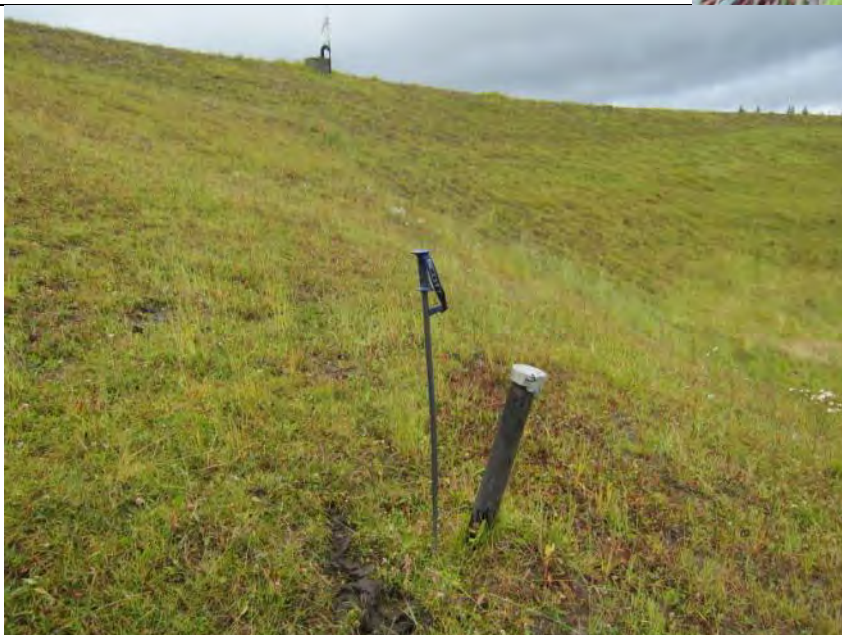
**(112) Current monitoring program includes piezometer reading, but a condition inventory of each instrument is needed.**

Piezometer on buttress right of maximum section. Note leaning condition of casing.

- ☐ (85) PROVIDE SURFACE DRAINAGE FOR: \_\_\_\_\_
- ☒ (86) MONITOR: All instrumentation and submit data to CO Dam Safety annually (See item (95) below).

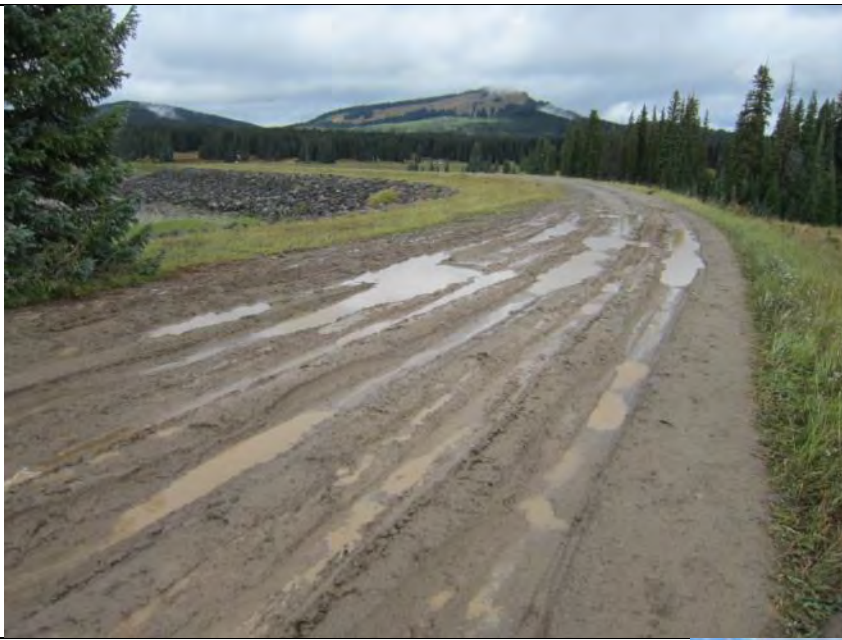
**(11) More significant ruts and puddles along dam crest right of maximum section between main dam and right freeboard dike. Could hinder access to Auxiliary dam if condition worsens. POOR rating for this section of crest.**

Ruts and puddles in unsurfaced portion of dam crest between main dam and right freeboard dike.

- ☒ (84) GRADE CREST TO A UNIFORM ELEVATION WITH DRAINAGE TO THE UPSTREAM SLOPE: along crest of Main dam and routinely grade or provide imported granular material for portion of crest along right freeboard dike.

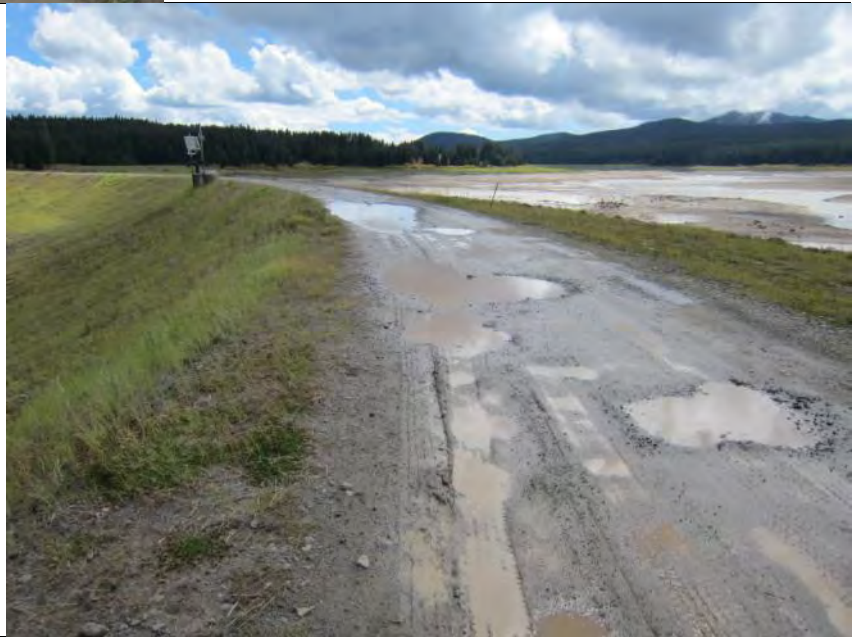
**Main Dam: (11) Rain during inspection reveals numerous puddles along main portion of dam. Most considered shallow and minor at this time, but condition could be improved with grading. ACCEPTABLE rating for this portion of crest only.**

Ruts and puddles in crest along maximum section of dam.

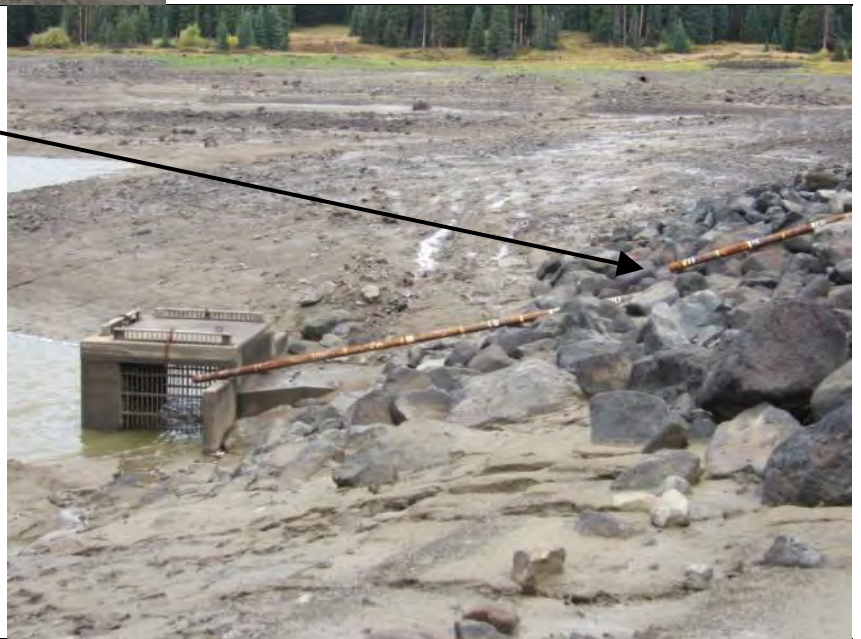
**(111) Gage rod disconnected at pipe joint just above outlet intake structure.**

Gage rod disconnected at pipe joint.

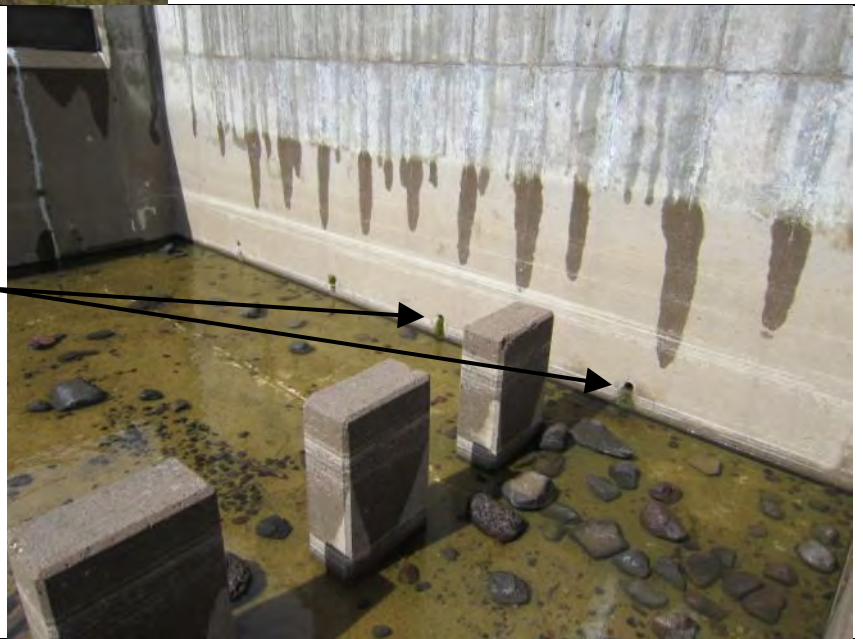
**(59) Most wall weep holes appear to have significant moss buildup. Floor drain water prevented close observation during the inspection.**

View of left stilling basin wall.  
Note moss build-up in weep holes.

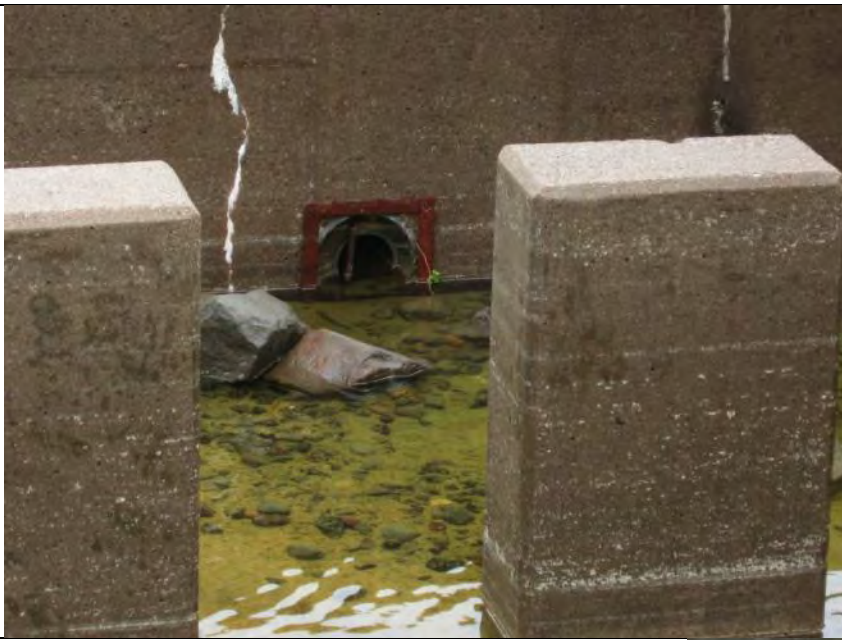
Stilling basin floor drain intake

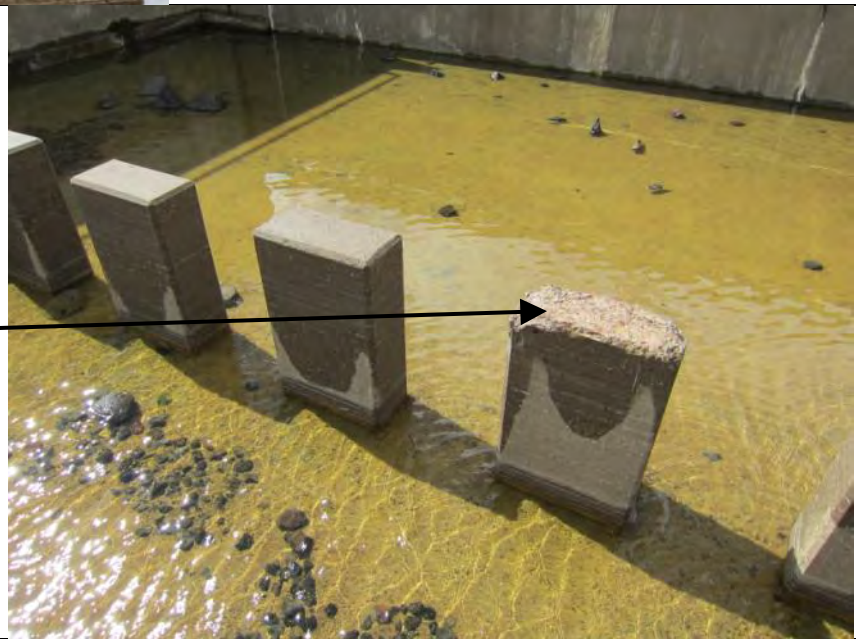
**All concrete structures appear in acceptable condition. (58) Top edge of several baffle blocks deteriorated, but appear structurally stable.**

Close-up of baffle blocks.  
Note minor deterioration of single baffle block.

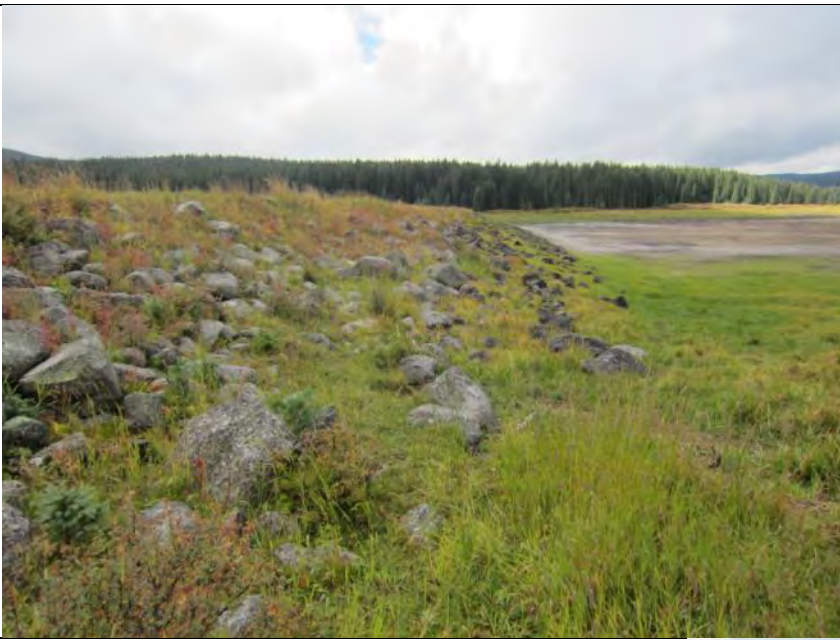
**Auxiliary Dam: (1) Riprap coverage varies along slope from full coverage to areas of sparse protection. (2) Wave erosion with scarps along high waterline, but condition appears stable.**

View along upstream slope of Auxiliary Dam from left abutment.

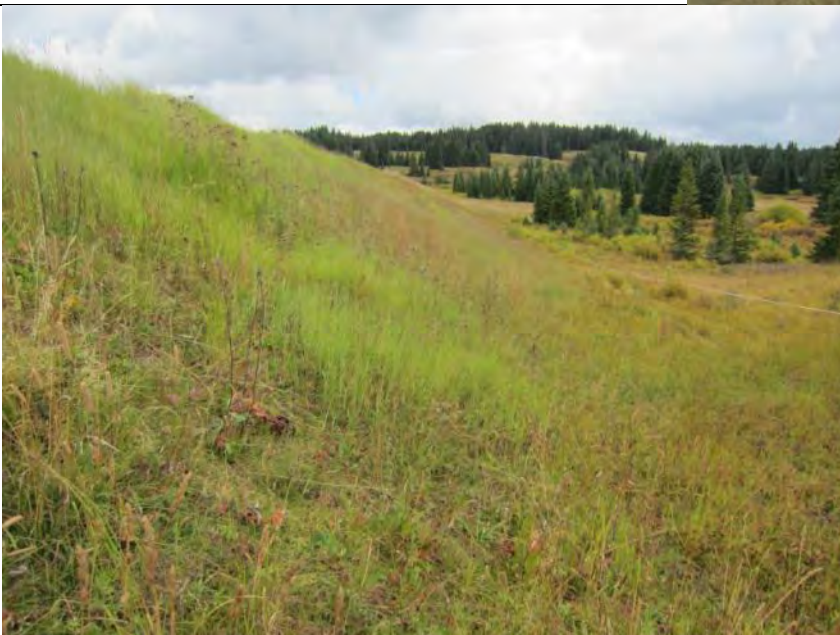
**Auxiliary Dam: Slope varies with historic bulges and depressions. No evidence of structural instability at this time. Overall good grass cover appears to prevent drainage erosion of uneven surfaces. (29) Numerous pocket gopher type rodent activity, but all appear shallow with minimal slope damage. All condition acceptable at this time.**

Overall view along downstream slope of Auxiliary Dam.

- ☒ (82) CLEAR TREES AND/OR BRUSH FROM: as needed for clear embankment surfaces on Auxiliary Dam.
- ☐ (83) INITIATE RODENT CONTROL PROGRAM AND PROPERLY BACKFILL EXISTING HOLES: \_\_\_\_\_
