When replying, please refer to:  
**OVERLAND #1 DAM, DAMID: 400422**  
**Water Division 4, Water District 40**

**SUBJECT:** Engineer's Inspection Report

# ENGINEER'S INSPECTION REPORT

DAM NAME: OVERLAND #1	T: 110S R: 0920W S: 23	COUNTY: DELTA	DATE OF INSPECTION: 7/27/2016
DAM ID: 400422 YRCompl: 1987	DAM HEIGHT(FT): 60.0	SPILLWAY WIDTH(FT): 75.0	PREVIOUS INSPECTION: 9/16/2015
CLASS: High hazard	DAM LENGTH(FT): 3200.0	SPILLWAY CAPACITY(CFS): 4367.0	NORMAL STORAGE (AF): 5828.0
DIV: 4 WD: 40	CRESTWIDTH(FT): 20.0	FREEBOARD (FT): 6.0	SURFACE AREA(AC): 252.0
EAP: 8/4/2012	CRESTELEV(FT): 9897.0	DRAINAGE AREA (AC.): 6200.0	OUTLET INSPECTED: 9/4/2009

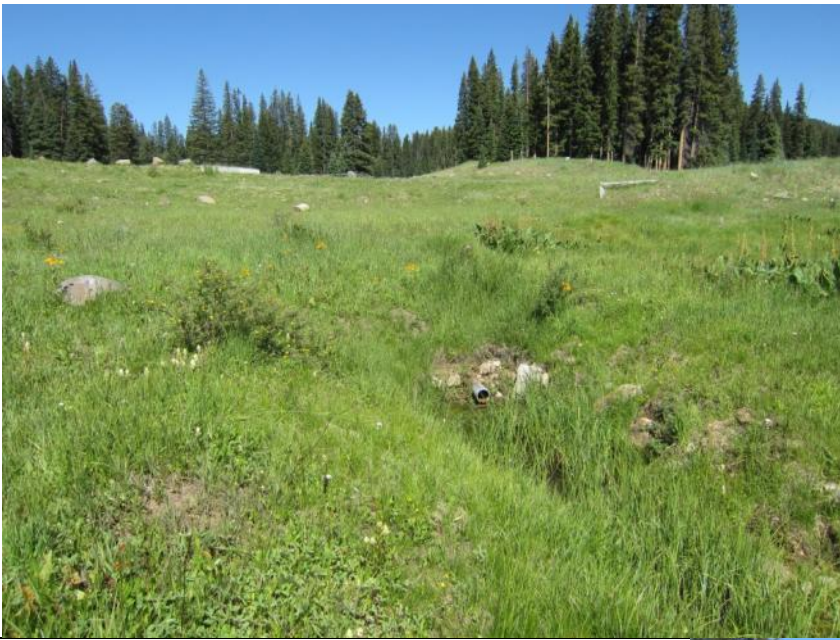
Spillway floor drain outfall: dry; no flow (see Spillway Section for additional discussion).

Looking upstream at outfall and discharge channel for Spillway Stilling Basin Floor Drain.

- ☒ (89) OTHER **Unclog or repair spillway floor drain to allow full draining of spillway basin; Clean moss from spillway wall weep holes.**

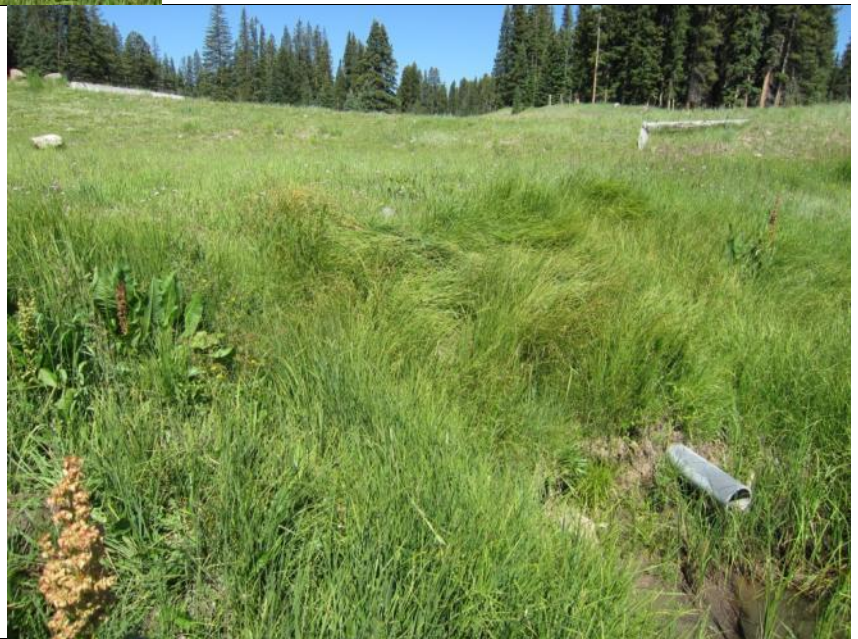
Spillway under drain outfall: trickle flow

Spillway Stilling Basin Underdrain outfall.

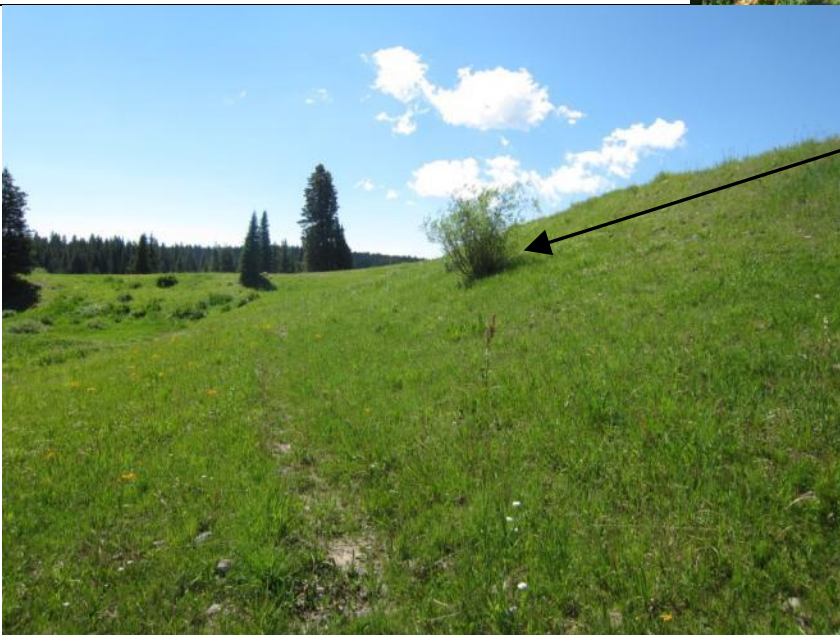
**(63)(64) Small to moderate size brush and small pines periodic on all slopes should be sprayed and or removed.**  
**(63) Willows in spillway channel should be fully removed.**  
**(68) Repair spillway floor drain. Clean moss from spillway wall weepholes.**  
**See Action Items on page 3 for additional maintenance items.**

Example of isolated brush that should be removed from dam.

- ☒ (82) CLEAR TREES AND/OR BRUSH FROM: **from spillway channel and all embankment surfaces as needed for clear access and visibility. Small pines among riprap on upstream slope should be removed**

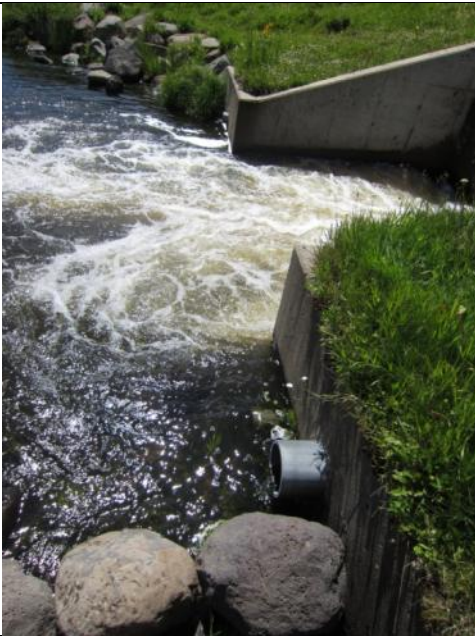
Outlet works conduit drain outfalls: both submerged by tailwater during inspection.

Wingwalls of baffled impact basin with various drain outfalls. Lower outfalls submerged at this outlet flowrate.

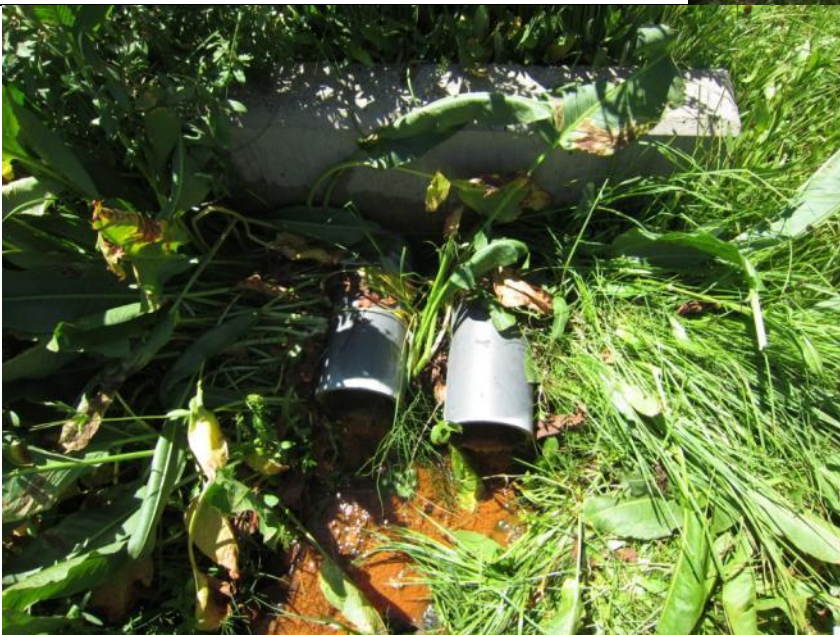
"Drain B " outfalls (left and right): Flowing several gallons per minute; clear. Moss and soil buildup at end of pipes obstructs free flow condition for volume versus time measurements.

"Drain B" headwall and drain pipe outfalls.

- ☒ (87) DEVELOP AND SUBMIT AN EMERGENCY ACTION PLAN: **Update and distribute with assistance from CO Dam Safety**
- ☒ (88) OTHER **Clean muck from toe drains 'A' and 'B' outfalls to facilitate monitoring.**

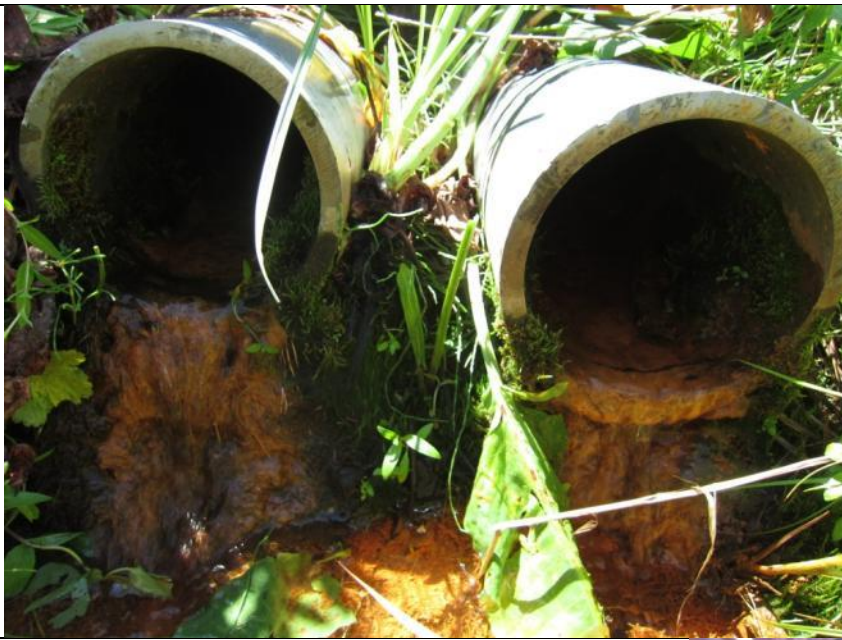
Close-up of 'Drain B' outfalls.

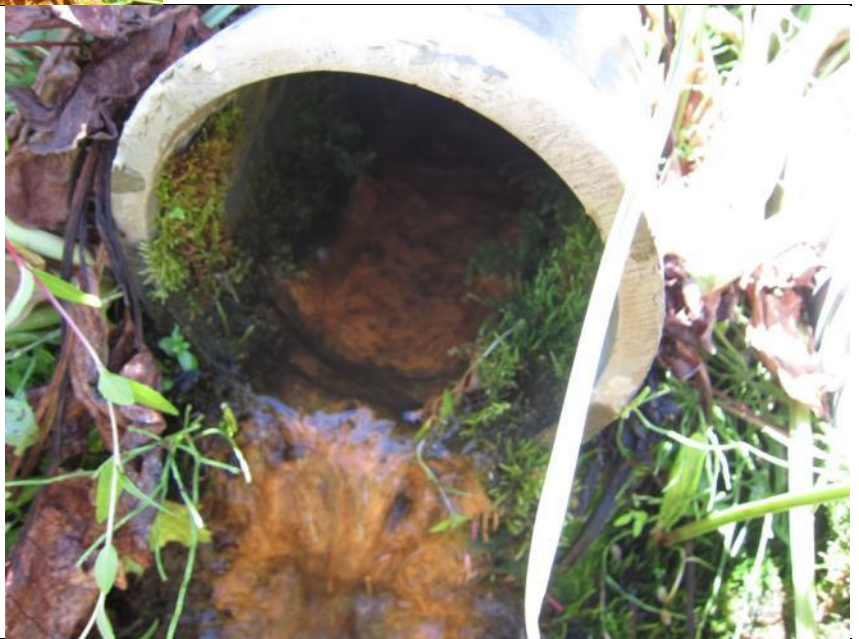
"Drain A" outfall: Difficult to locate due to dense tall grass, but found during inspection; damp, no flow.

'Drain A' pipe outfall.

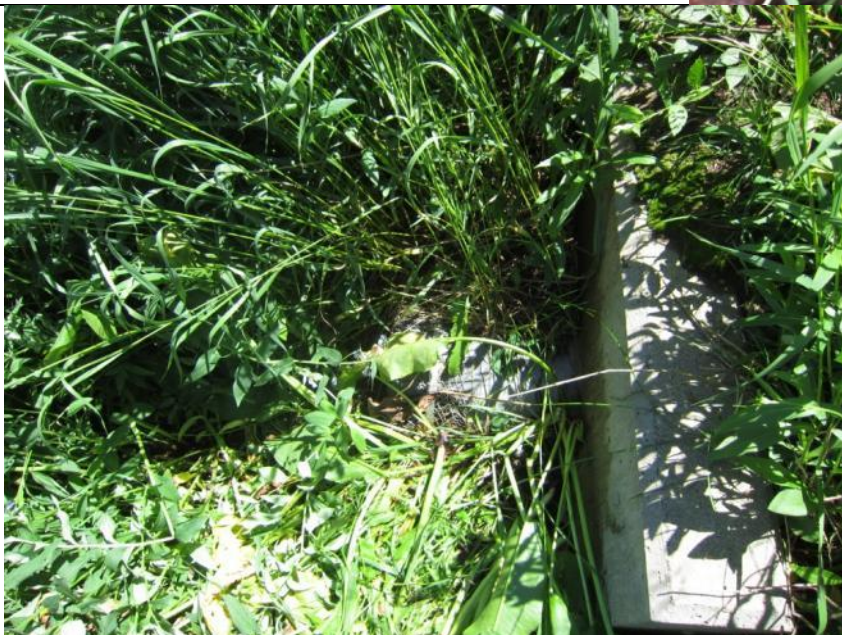
'Drain A' headwall and pipe outfall.

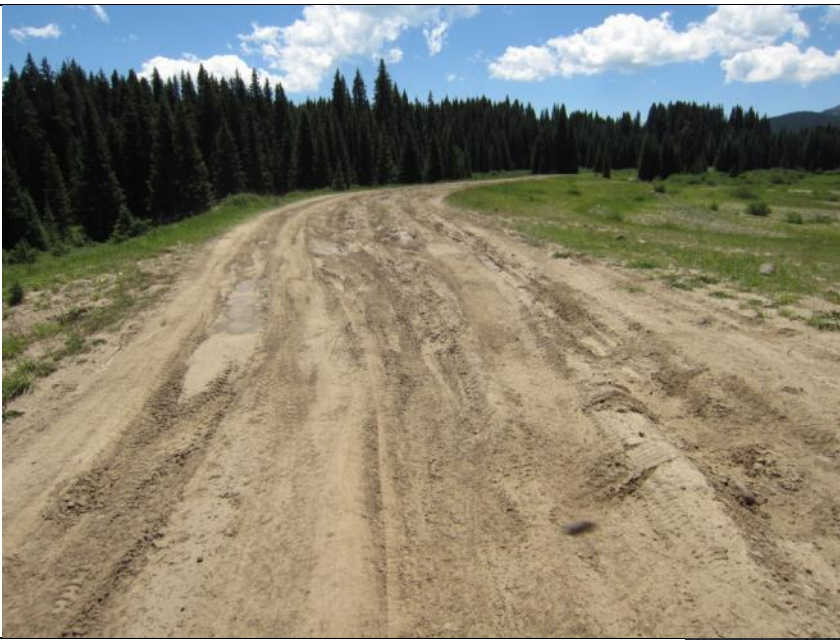
**(11) Extensive rutting begins at right end of Main dam and extends along right wing dike of dam. POOR rating for this section only.**

Heavily rutted crest section along far south (right) freeboard dike portion of dam.

- ☐ (83) INITIATE RODENT CONTROL PROGRAM AND PROPERLY BACKFILL EXISTING HOLES: \_\_\_\_\_
- ☒ (84) GRADE CREST TO A UNIFORM ELEVATION WITH DRAINAGE TO THE UPSTREAM SLOPE: **and repair ruts between Main dam and right wing dike**

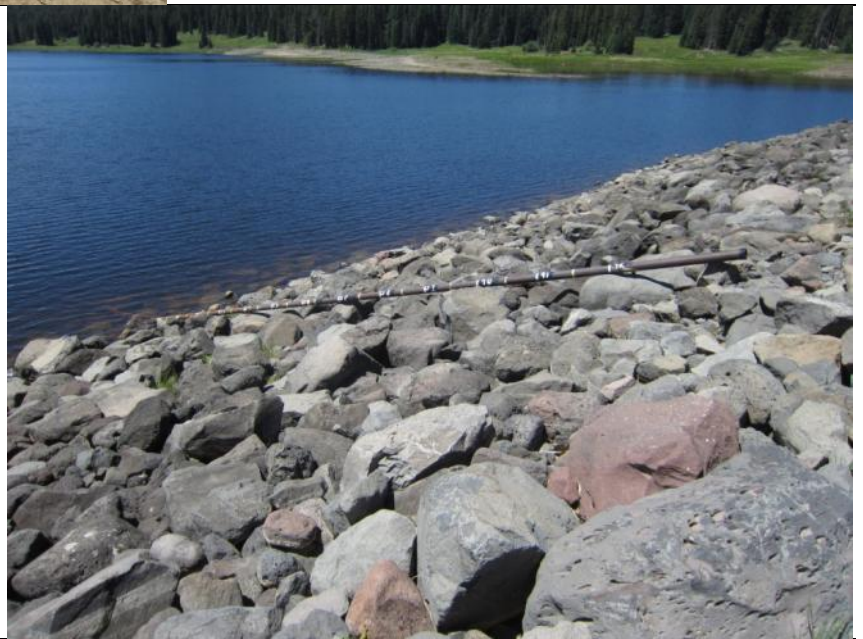
(111) Known problem with gage rod at lower reservoir level. See 2015 inspection report for additional information.

Gage rod laying along top of riprap on upstream slope.

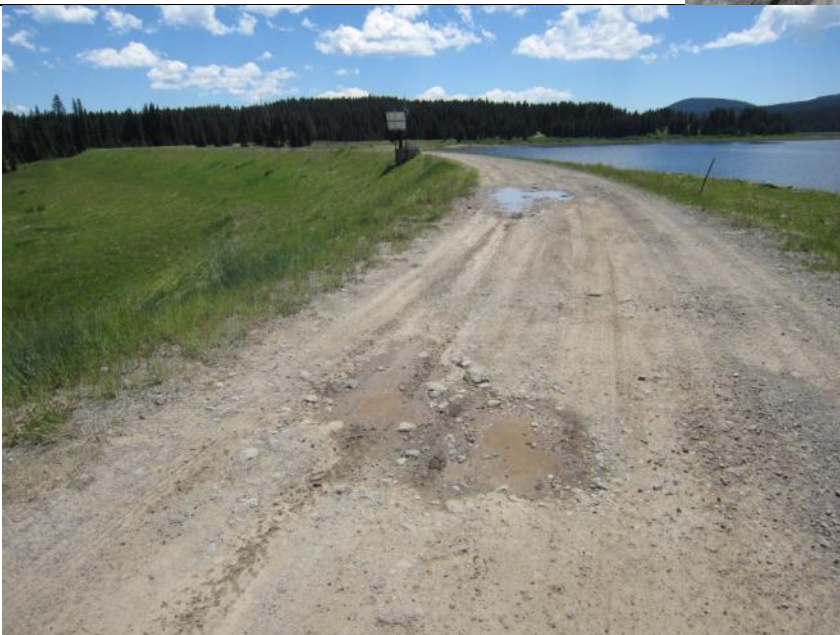
**Main dam: (11) Small to moderate sized potholes forming on crest of main dam, particularly around the outlet controls manhole. Elevation, width, and alignment all appear uniform through main section of dam.**

Typical puddles on dam crest near maximum section of dam.

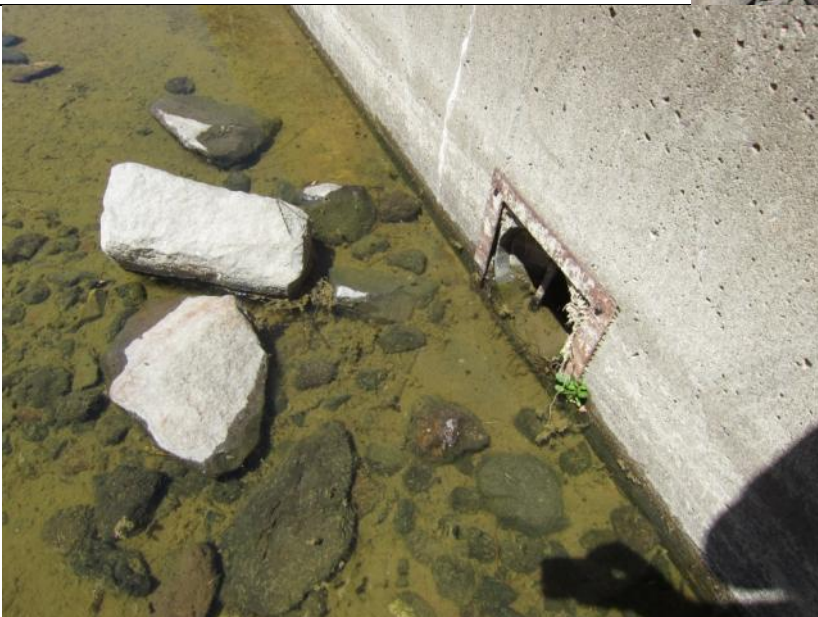
(59) Spillway floor drain plugged or broken and does not allow for full drainage of basin. 8-12 inches of water remains in basin.

Spillway stilling basin floor drain intake. 8-12 inches of standing water constantly remains in stilling basin, indicating possible plugging of floor drain pipe.
