When replying, please refer to:
OVERLAND #1 DAM, DAMID 400422
Water Division 4, Water District 40

SUBJECT: Engineer's Inspection Report

ENGINEER'S INSPECTION REPORT

DAM NAME: OVERLAND #1	T: 110S R: 0920W S: 23	COUNTY: DELTA	DATE OF INSPECTION: 7/23/2018
DAM ID: 400422 YRCompl: 1987	DAM HEIGHT(FT): 60.0	SPILLWAY WIDTH(FT): 75.0	PREVIOUS INSPECTION: 8/7/2017
CLASS: High hazard	DAM LENGTH(FT): 3200.0	SPILLWAY CAPACITY(CFS): 4367.0	NORMAL STORAGE (AF): 5828.0
DIV: 4 WD: 40	CRESTWIDTH(FT): 20.0	FREEBOARD (FT): 6.0	SURFACE AREA(AC): 252.0
EAP: 8/4/2012	CRESTELEV(FT): 9897.0	DRAINAGE AREA (AC.): 6200.0	OUTLET INSPECTED: 9/4/2009

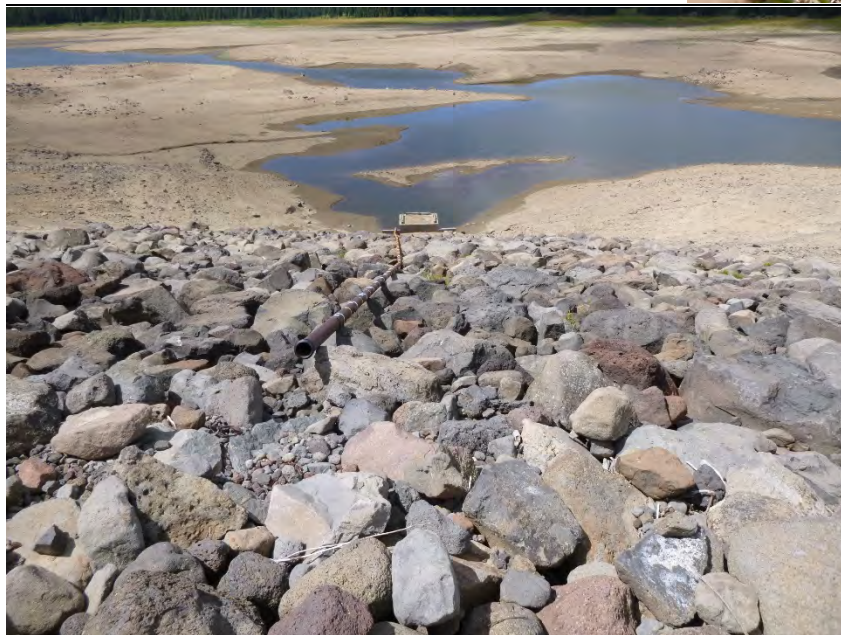
(111) Gage rod alignment appears skewed and lowest section of pipe is disconnected and displaced. Uncertain of gage rod accuracy at this time. Also, one-foot paint increments difficult to read.
(112) Piezometer inventory, condition assessment, flushing, and historic data reduction reportedly completed by Owner's engineer in late 2017. Report of findings and long-term monitoring plan to be completed by end of 2018.
(114) (115) Survey monuments and drain outfalls initially not part of engineer's evaluation and long-term monitoring plan. These instruments were discussed and added to the scope of work during the inspection for final reporting.

View looking downslope along pipe used as reservoir gage rod (note skewness).

- ☒ (89) OTHER **Repair gage rod and verify elevation markings with reservoir capacity. Remark rod for clarity and accuracy.**
- ENGINEERING - EMPLOY AN ENGINEER EXPERIENCED IN DESIGN AND CONSTRUCTION OF DAMS TO: (Plans and Specifications must be approved by State Engineer prior to construction.)

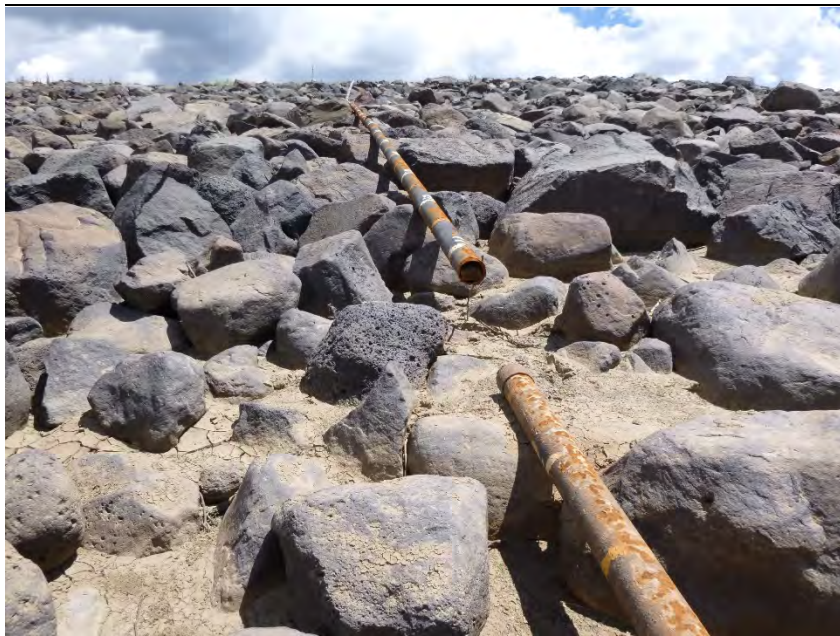
Lower portion of gage rod pipe disconnected and displaced.

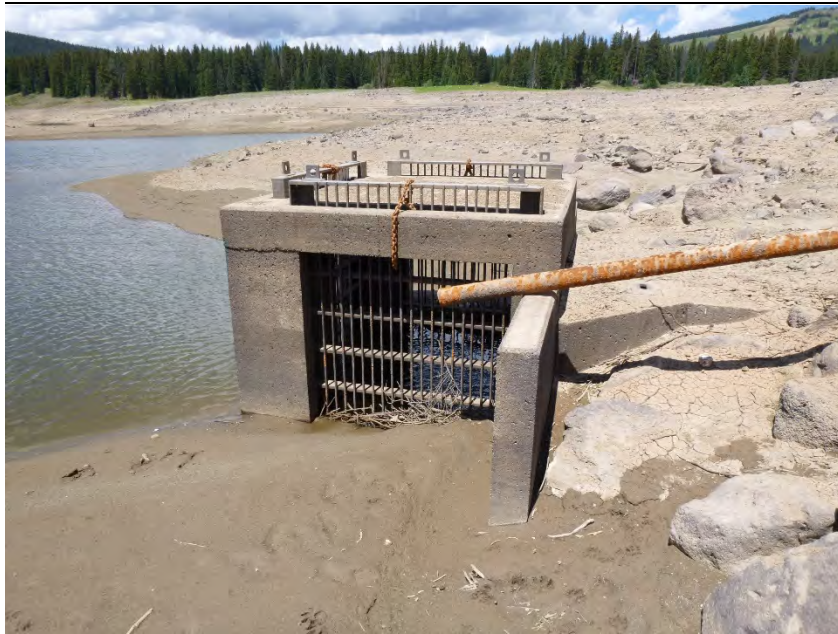
Outlet discharging and not operated during inspection, but no reported or known problems with reservoir releases during 2018 irrigation season.
Upstream intake structure and trashracks exposed at current empty reservoir level. Minor debris and sediment accumulation at trashracks, but generally no problems observed.

Note minor sediment and debris at base of trashrock.

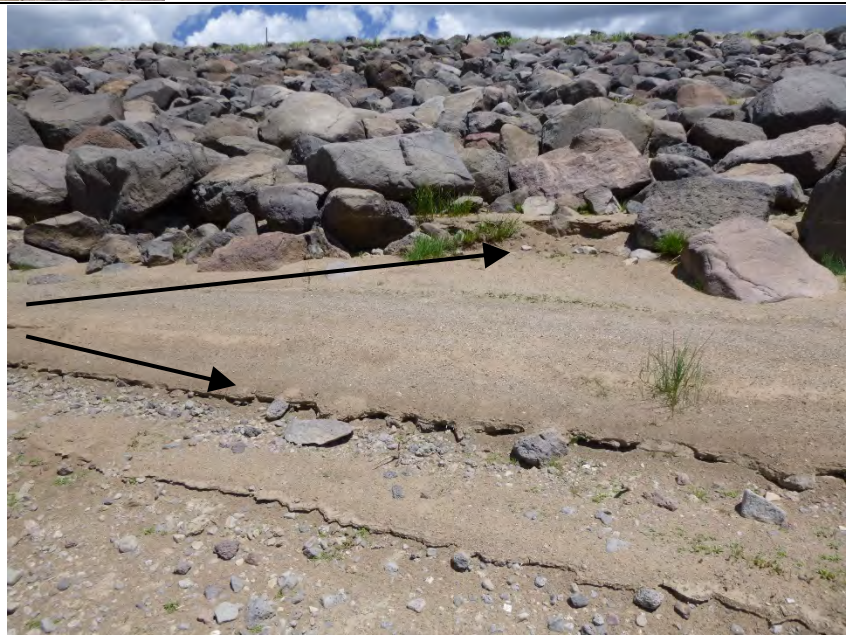
Full slope exposed with empty reservoir during inspection. Near full riprap coverage along maximum section of embankment. Few areas of beaching at upstream toe transition from riprap to reservoir bed. Some sand accumulation appears to have been pumped from under riprap by wave action. No problems or concerns observed.

Typical area of possible sediment pumping and beaching at upstream toe.

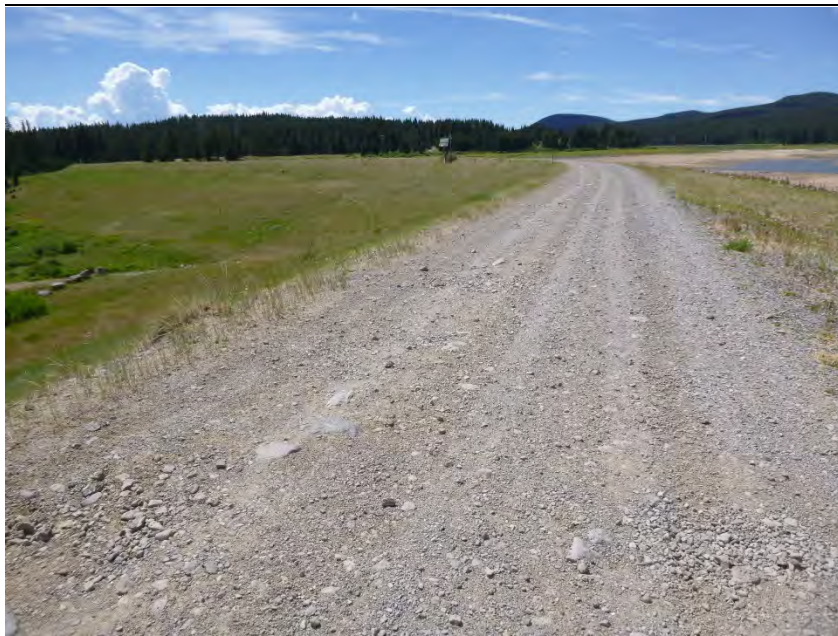
Imported gravel treatment from left end near spillway to dogleg bend just before start of right end wing dike. Only minor (11) puddles observed in this section and appearance is fairly uniform. Crest of right wing dike appears mainly native embankment material with heavy rutting from vehicular traffic during wet periods. Poor drainage and rough surface. No significant change from recent past inspections, but crest in this section remains in Poor condition.

Typical view along dam crest. Note minor puddles in foreground.

(68) Repair rut damage and grade right end of Main dam crest. Mild grading and filling in of potholes needed on remainder of crest. Grade with slight inclination to upstream slope for drainage; do not crown center.

- ☒ (84) GRADE CREST TO A UNIFORM ELEVATION WITH DRAINAGE TO THE UPSTREAM SLOPE: **along right end of Main Dam and fill potholes along remainder of crest.**

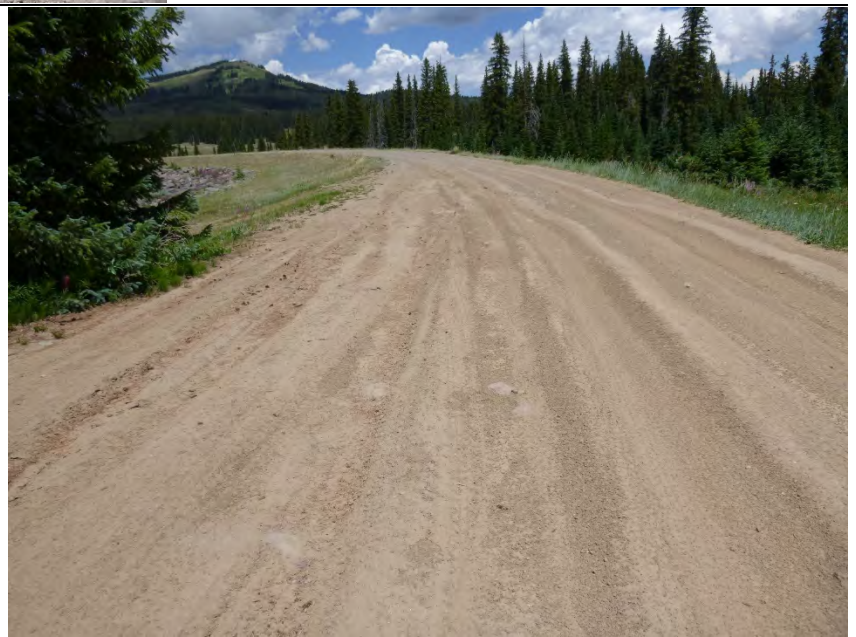
Split Acceptable/Poor rating with poor condition confined to right wing dike rutting.

Heavily rutted and unprotected dam crest along right wing dike.

Owner indicates USFS road crews are scheduled to repair and grade the Main Dam crest in 2019. This is acceptable as long as problem to not worsen prior to repair and the grading is conducted in accordance with dam safety standards (i.e. uniform elevation with drainage to upstream slope; do not crown center).

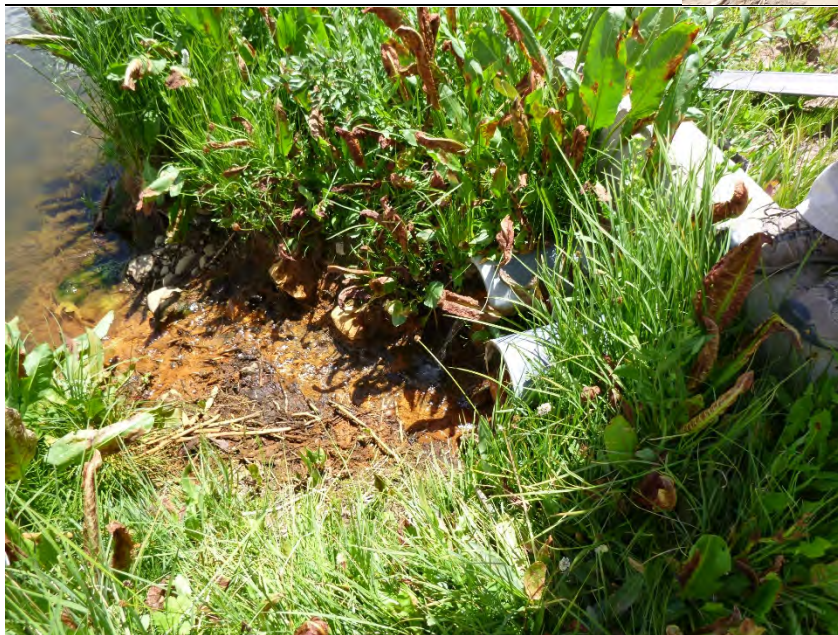
No wet areas on embankment or beyond downstream toe with current empty reservoir. All drain outfalls located and observed either dry or very little flow (trickle), except for buttress drain outfall B-2 flowing at estimated 2 gpm. All seepage conditions acceptable based on current reservoir level and evidence of activity at recent past higher levels.

Drain outfalls 'B-1' (right in photo) and 'B-2' (left in photo).

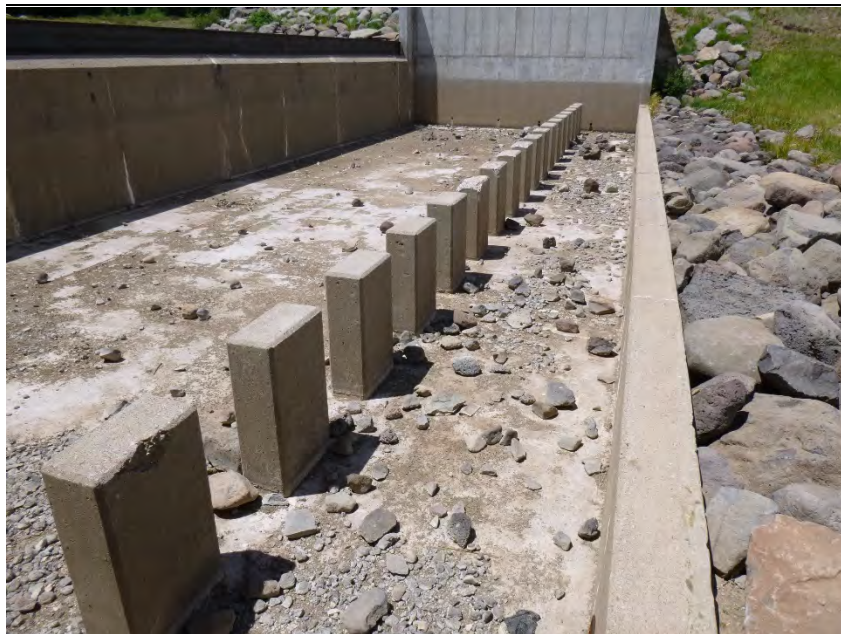
(59) Numerous rocks in stilling basin. No apparent damage to floor at this time, but rocks could cause ball milling erosion at high spillway flows.
Some concrete deterioration on tops of two or three baffle blocks. All blocks appear structurally sound and functional at this time.
Stilling basin floor drained and fully accessible. Several training wall relief drains observed damp, some with moss at outfall.
All cracks in concrete appear similar to past inspections with no apparent worsening condition.
Access road across channel rough, but easily accessible by 2WD SUV vehicle.

Close-up along spillway downstream sill and baffle blocks. Note rocks in stilling basin.

- ☒ (87) DEVELOP AND SUBMIT AN EMERGENCY ACTION PLAN: **Update and distribute with assistance from CO Dam Safety**
- ☒ (88) OTHER **Remove all rocks from spillway stilling basin to prevent 'ball milling' erosion.**

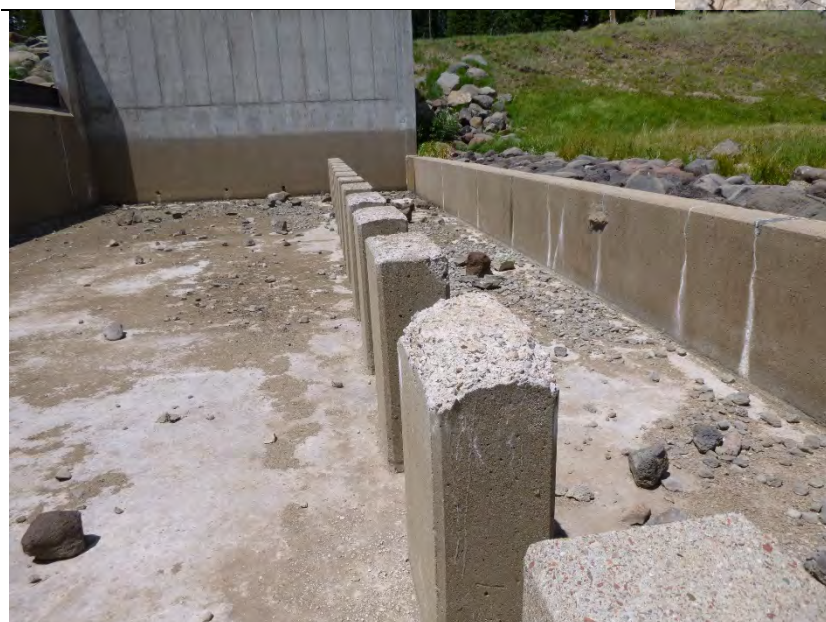
Close-up of deteriorated concrete on tops of several baffle blocks.
