**COLORADO**  
**Division of Water Resources**  
Department of Natural Resources  
Dam Safety

When replying, please refer to:  
**OVERLAND #1 DAM, DAMID 400422**  
**Water Division 4, Water District 40**

**SUBJECT:** Engineer's Inspection Report

# ENGINEER'S INSPECTION REPORT

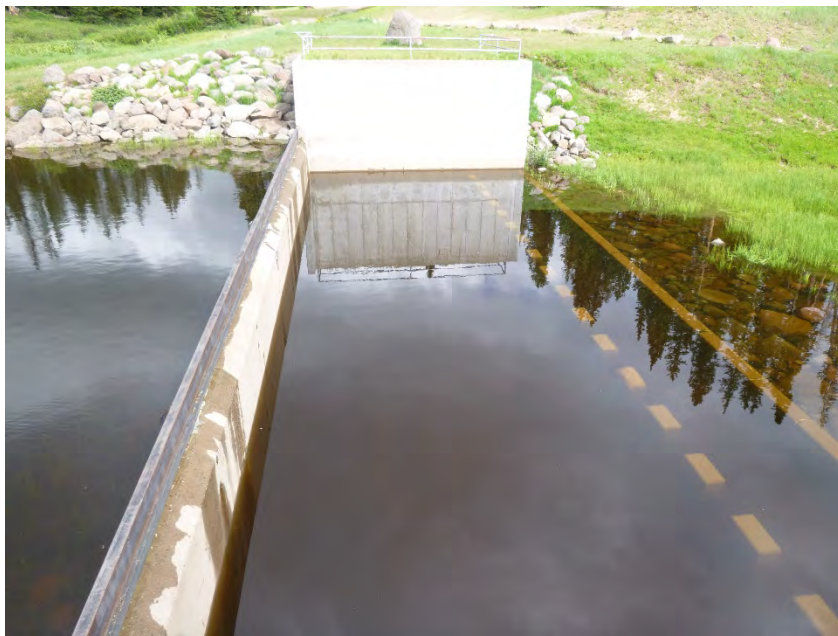
Spillway stilling basin

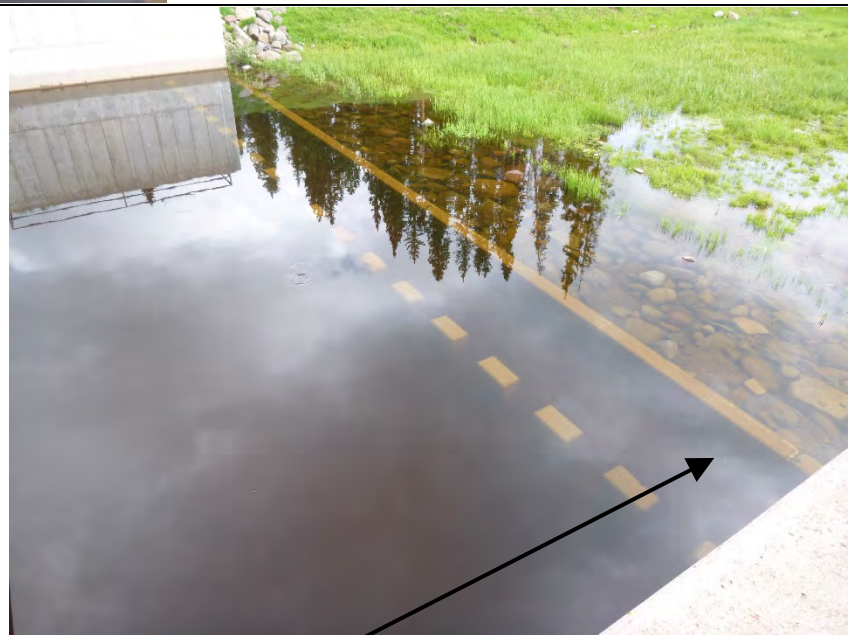
**(59) Stilling basin submerged during inspection due to obstructed drain.**

**Spillway condition acceptable, but repair of obstructed stilling basin drain judged as a critical maintenance item for the spillway to remain in a safe condition.**

Stilling basin baffle blocks and downstream weir.  
 Arrow indicates approx. location of submerged  
 and obstructed drain.

**(68b) Repair spillway stilling basin drain prior to Winter 2019/20 shutdown.**

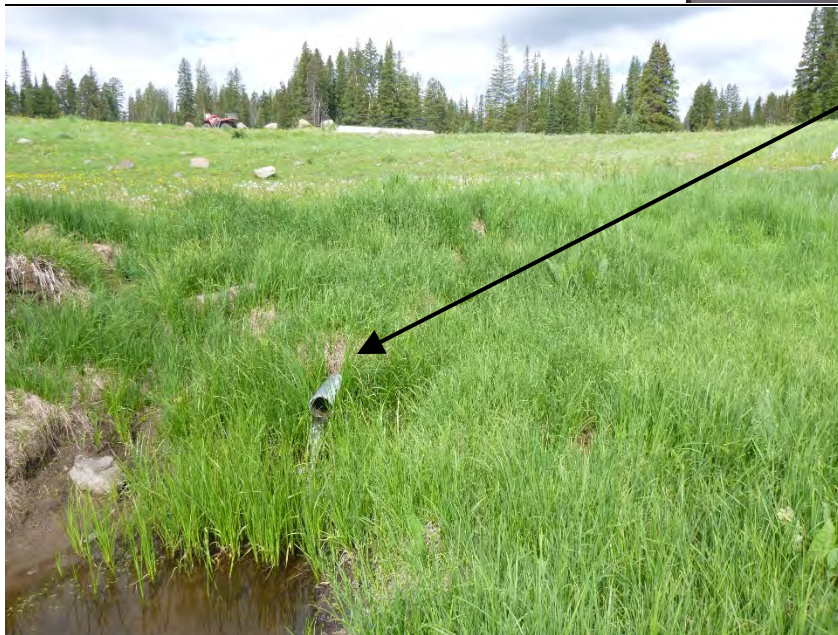
Downstream outfall of stilling basin drain flowing  
 less than half full.

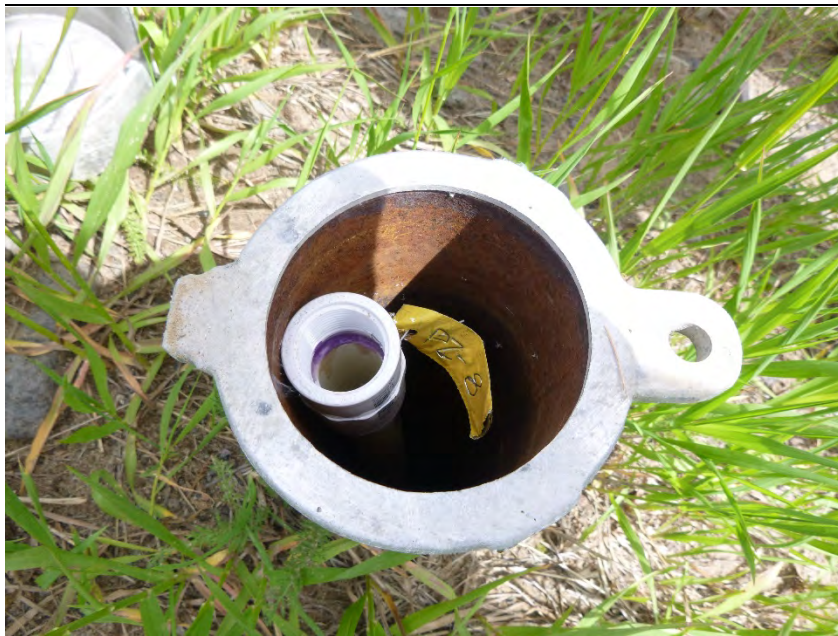
**(112)(115) Piezometer and seepage monitoring reportedly occurring periodically, but no seepage monitoring data reported for 2017 or 2018.**

Typical piezometer casing and tube.

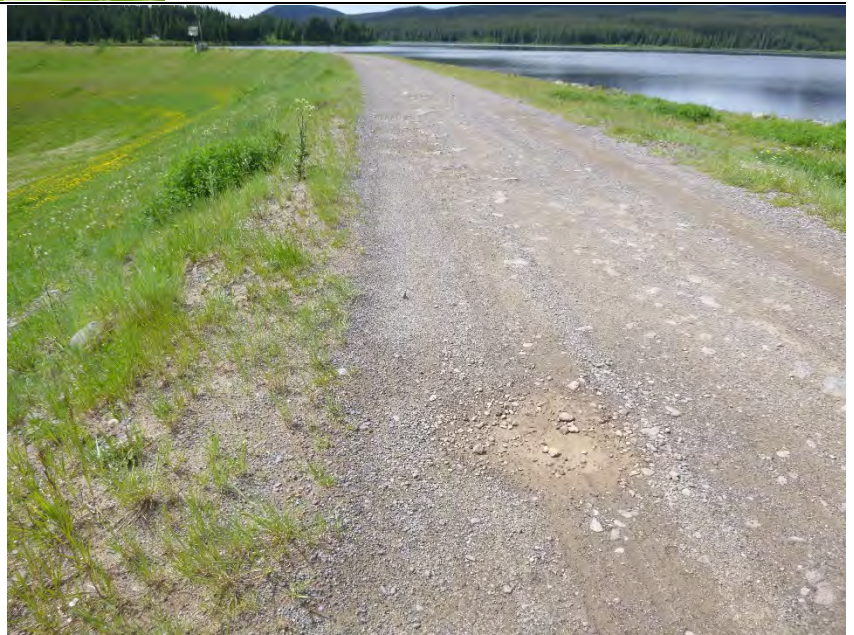
**(11) Numerous ruts along far right end of dam as observed over recent past years. (11) Numerous small (12-inch diameter) to medium sized (4-ft plus) potholes periodic along main portion of embankment crest. All observed shallow (<4") and not a significant safety concern at this time. Drainage varies, but no adverse erosion paths observed.**

Typical view along dam crest near maximum section.

**(68a) Repair rut damage and grade right end of Main dam crest. Mild grading and filling in of potholes needed on remainder of crest. Grade crest with slight inclination to upstream slope for drainage; do not crown center.**

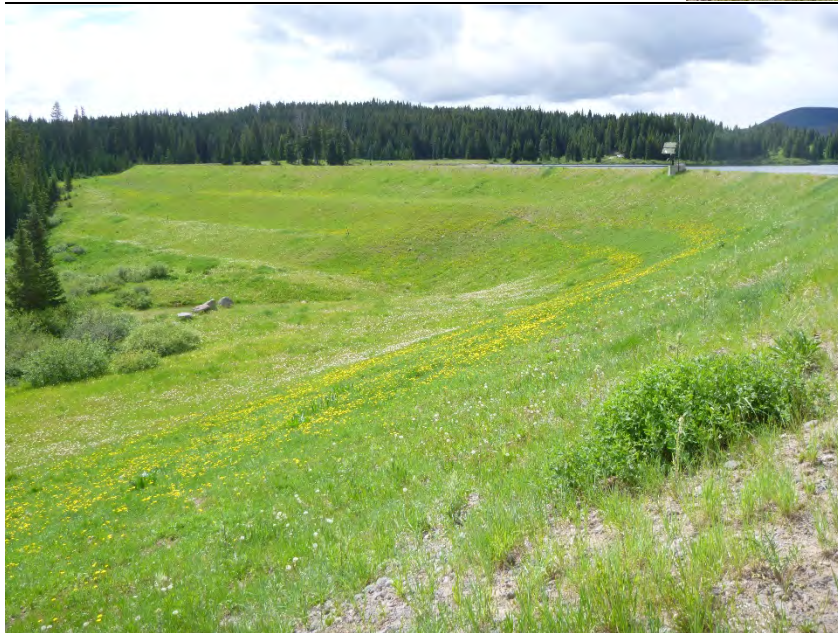
**Good conditions observed all along Main dam downstream slope. Past surface erosion areas seemed to have self-healed and good grass cover appears to resist surface drainage erosion. Slope is uniform with near as-constructed condition.**

Overall view of downstream slope near maximum section.

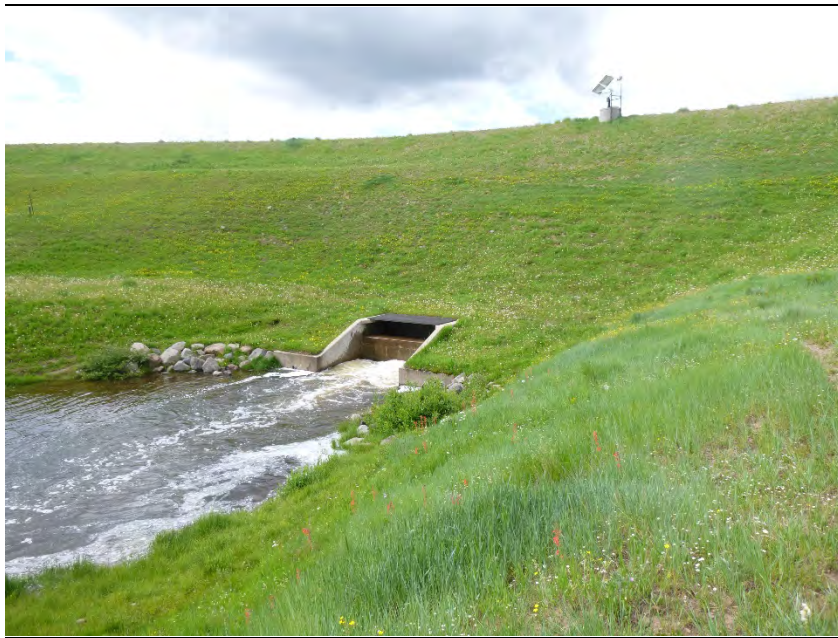
Maximum section along outlet works alignment.

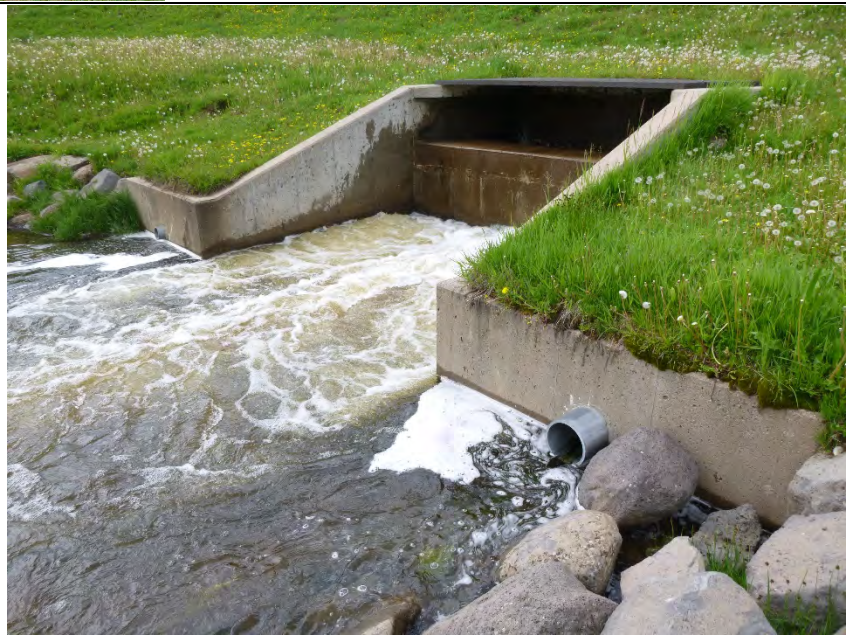
**Outlet discharging during inspection with no problems observed. No known problems with outlet works operation and performance.**

Close-up of outlet structure.

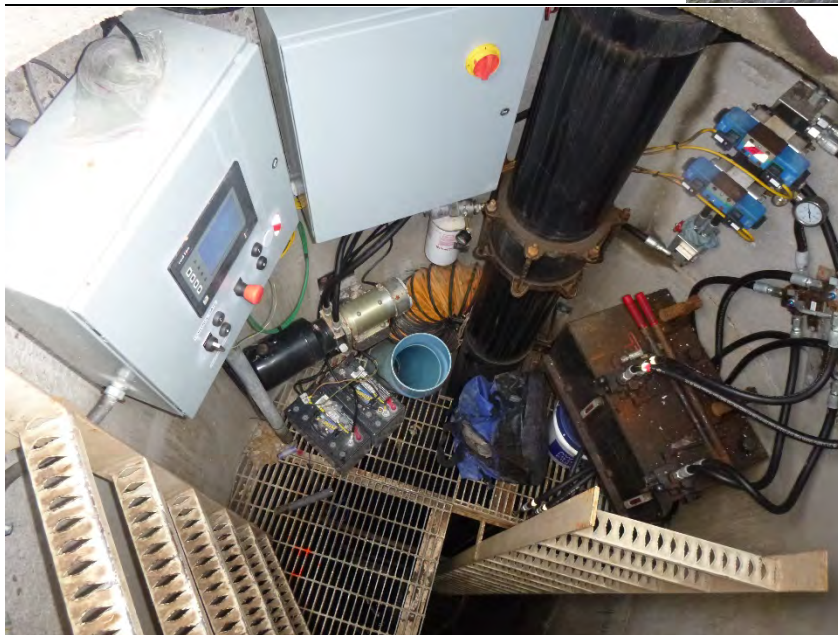
Outlet valve controls located in vault on crest of dam.

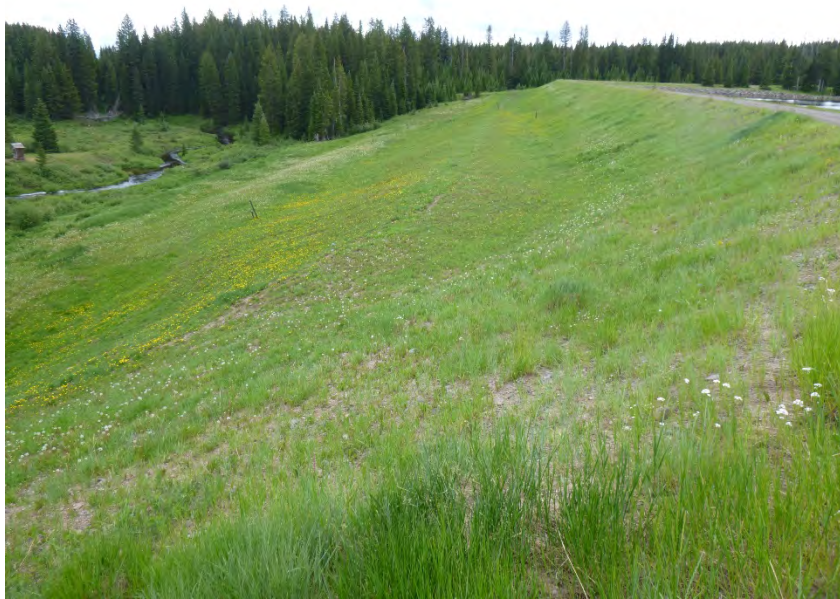
Right downstream slope.

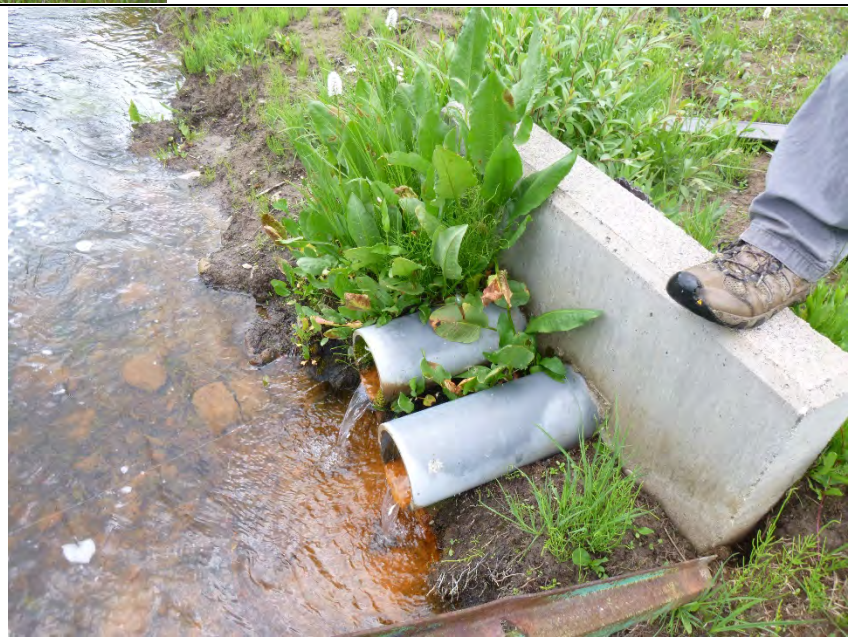
**All seepage appears contained to engineered drains. No apparent free seepage on embankment slope or along toe of dam.**

Toe drain outfalls.

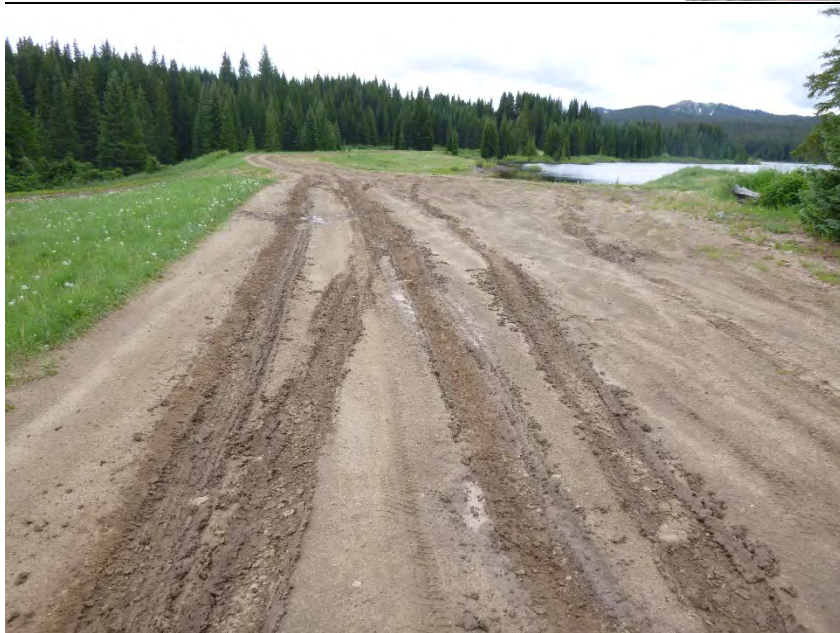
**Split rating with POOR conditions along right wing dike, but ACCEPTABLE conditions along main portion of both dams.**

Dam crest along far right end of dam.

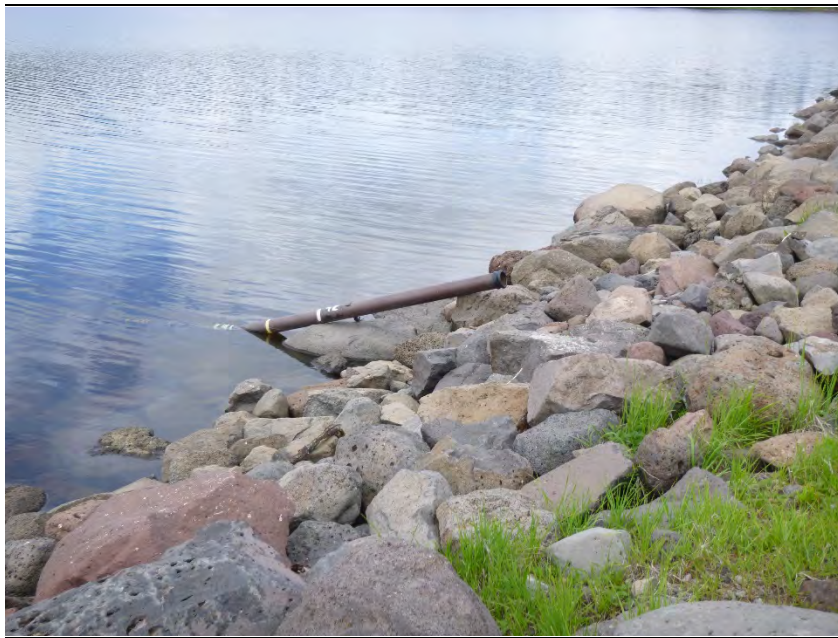
**(111) Upper end of gage rod exposed at this near full reservoir level appears acceptable. However, known skewed and disconnected portions at lower levels. Gage rod accuracy is in question and labeling varies in condition.**

Reservoir gage rod on upstream slope.

7/25/2019 - for replacement of gage rod (if concrete stem wall installation or other installation requiring embankment excavation).

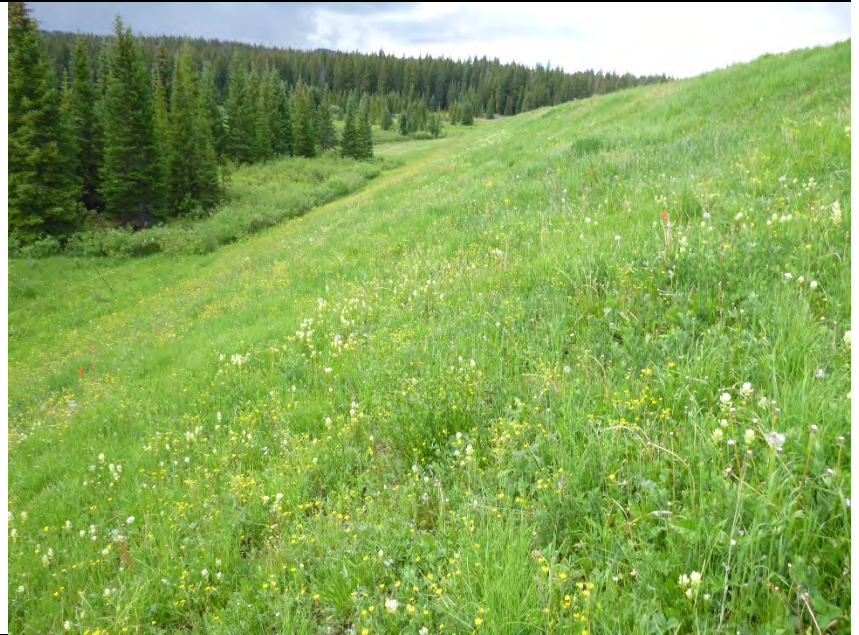
**Surface and slope inclination varies with few areas of bulge (26). However, all uneven areas appear historic with no evidence of movement, sloughing, cracking, or other signs of slope instability.**

Typical view along downstream slope of  
Auxiliary dam.

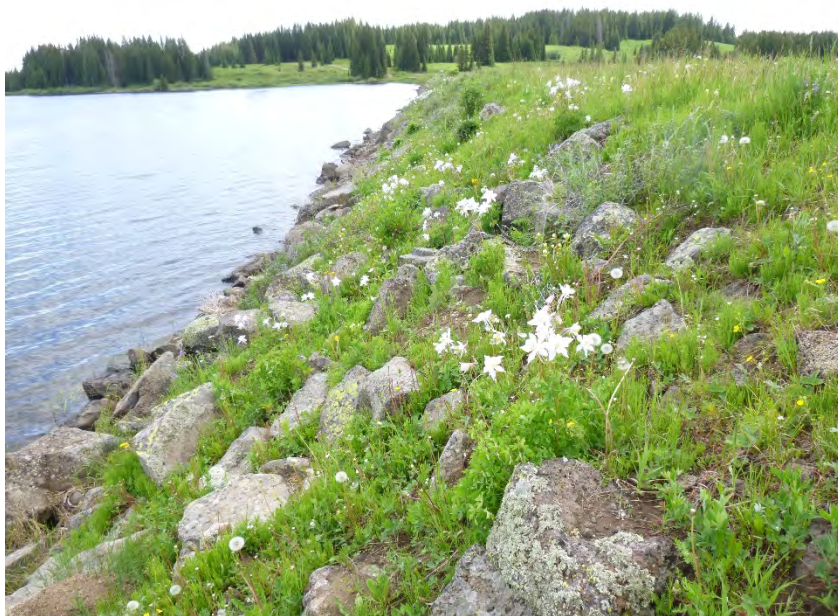
**(63)(64) Medium-sized brush and small pines should be removed from all embankment surfaces, particularly from upstream slope of Auxiliary Dam.**

Typical view along upstream slope of Auxiliary  
Dam.

7/25/2019 - all embankment surfaces, particularly from upstream slope of Auxiliary Dam.
