COLORADO
Division of Water Resources
Department of Natural Resources
Dam Safety Branch

SUBJECT: Engineer's Inspection Report

ENGINEER'S INSPECTION REPORT

DAM NAME: OVERLAND #1	T: 110S R: 0920W S: 22	COUNTY: DELTA	DATE OF INSPECTION: 8/6/2020
DAM ID: 400422 YRCompl: 1987	DAM HEIGHT(FT): 60.0	SPILLWAY WIDTH(FT): 75.0	PREVIOUS INSPECTION: 7/25/2019
CLASS: High hazard	DAM LENGTH(FT): 3200.0	SPILLWAY CAPACITY(CFS): 4367.0	NORMAL STORAGE (AF): 5828.0
DIV: 4 WD: 40	CRESTWIDTH(FT): 20.0	FREEBOARD (FT): 6.0	SURFACE AREA(AC): 252.0
EAP: 8/4/2012	CRESTELEV(FT): 9897.0	DRAINAGE AREA (AC.): 6200.0	OUTLET INSPECTED: 9/4/2009

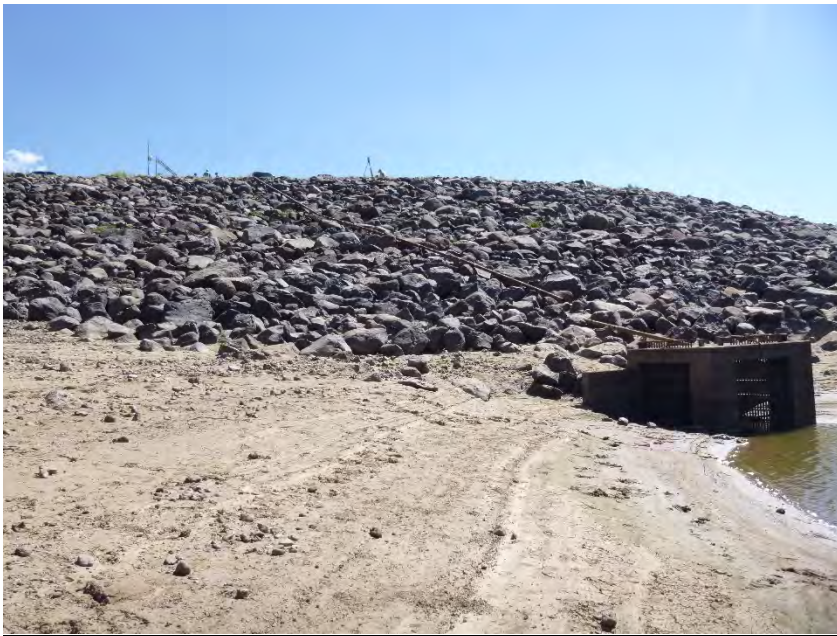
Upstream slope at maximum section with outlet intake structure in foreground.

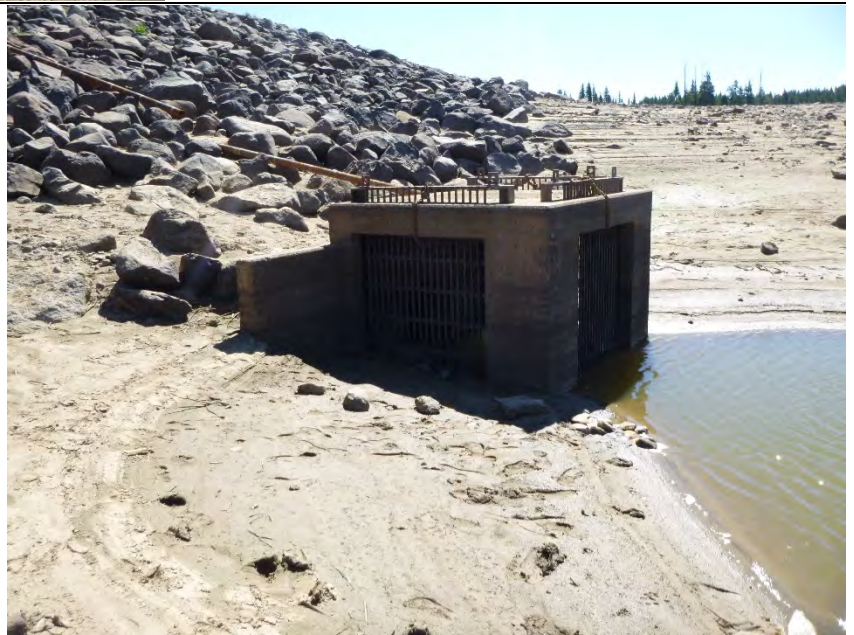
Outlet intake structure.

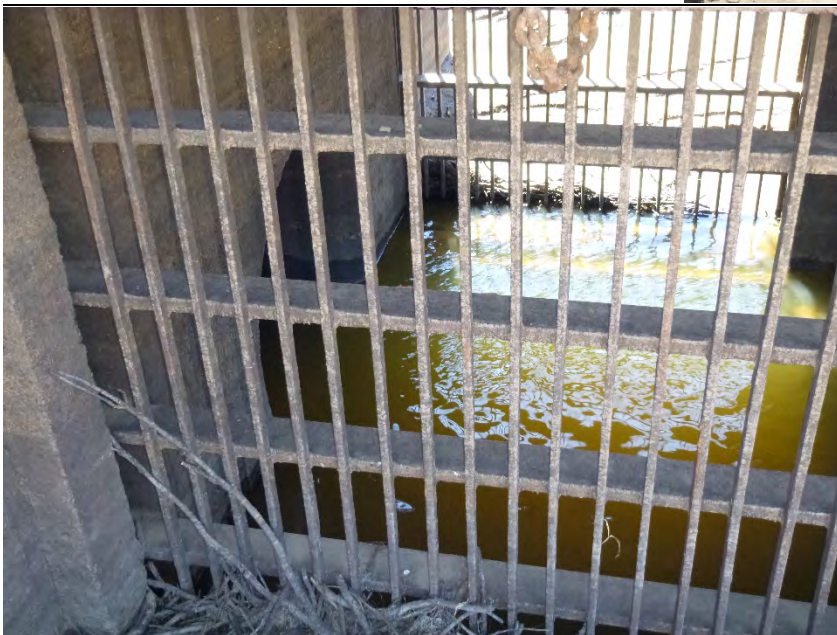
Close-up of outlet entrance taken through left trashrack grate.

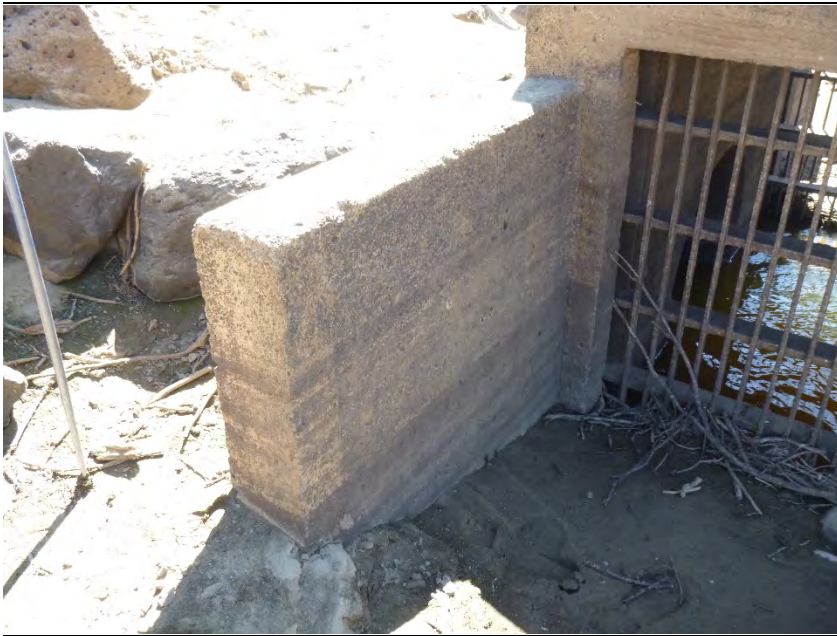
Left wingwall of outlet intake structure; possible connection point for proposed gage rod stem wall.

The Owner retained a professional engineer to design a concrete reinforced stem wall for replacement of the gage rod. The Engineer was present during the inspection and the proposed plan was reviewed at the gage rod site. The Owner is allowed to perform the following activities in advance of approval of plans and specifications:

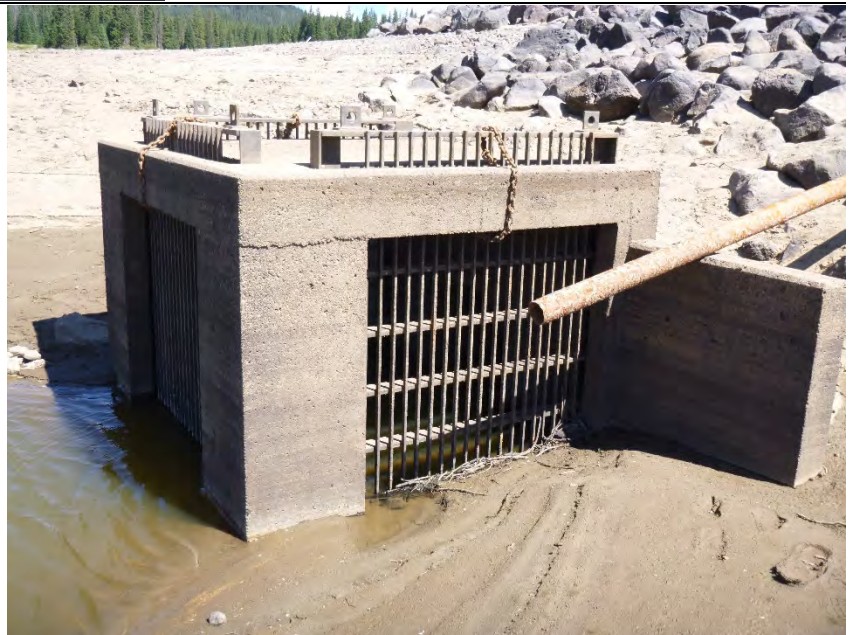
Right side of intake structure; pipe is current gage rod.

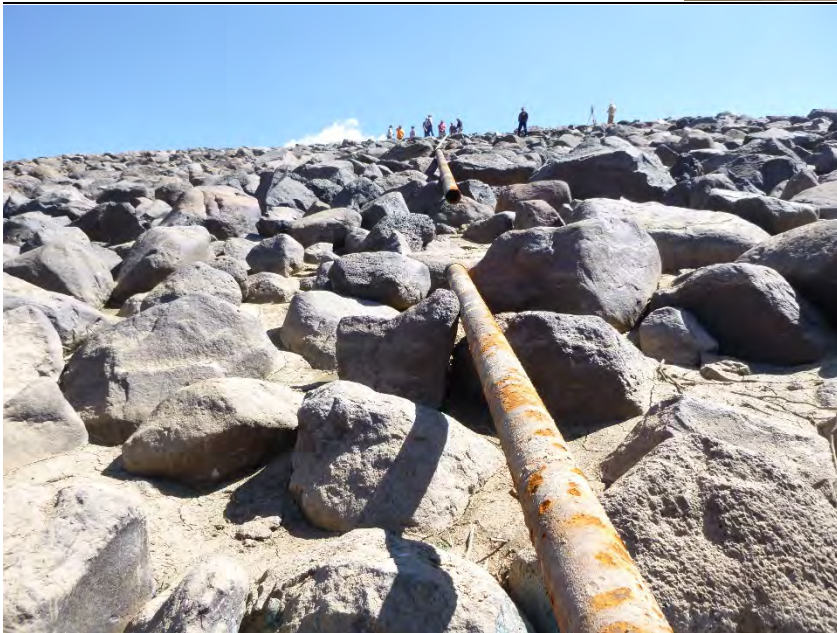
(111) Gage rod pipe skewed and disconnected at approximately half-height of embankment. Accuracy is questionable. Owner and Owner's Engineer anticipate submittal of engineering plans for replacement of gage rod shortly after inspection. See Page 3. Overall Conditions for additional discussion.

Gage rod pipe disconnected and displaced at about half embankment height.

7/25/2019 - for replacement of gage rod (if concrete stem wall installation or other installation requiring embankment excavation).

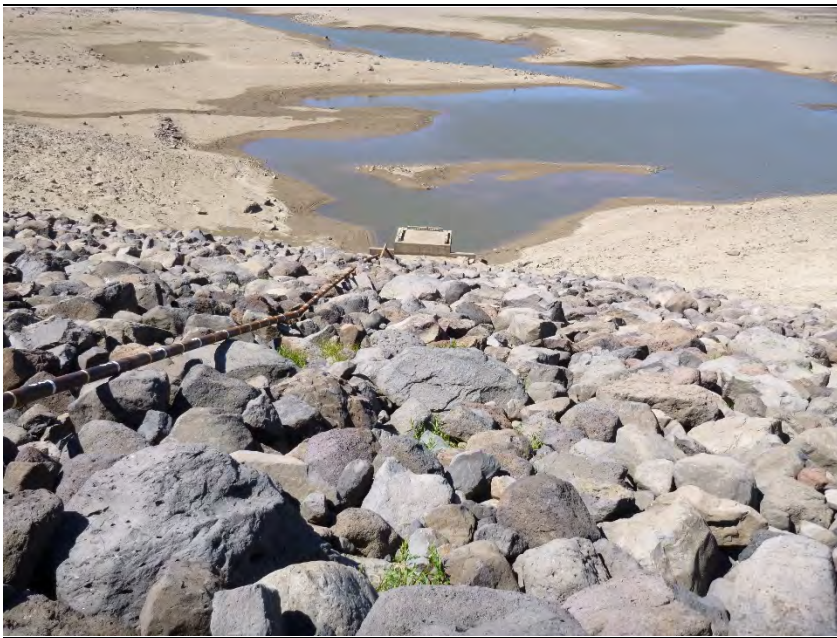
Looking down along upstream slope.

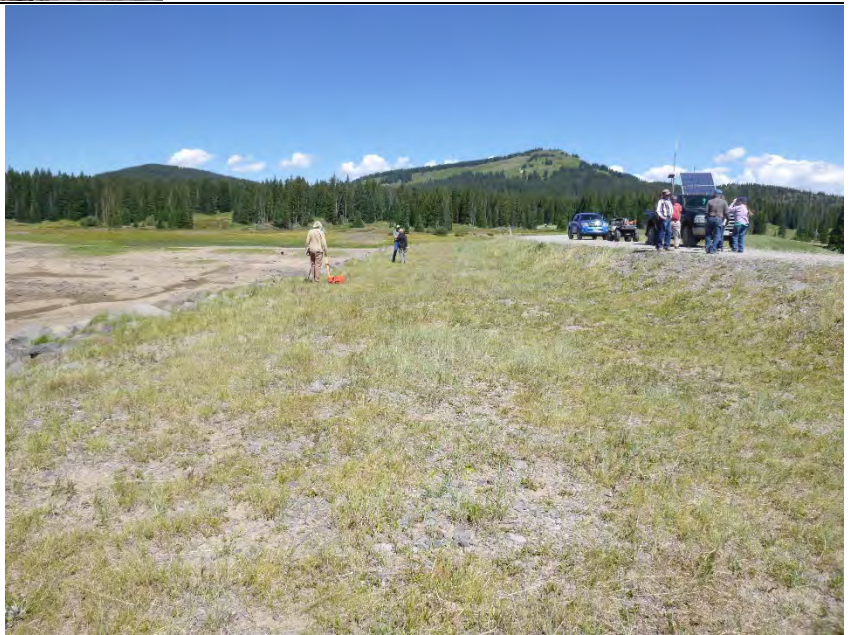
Typical view along widened crest section
(constructed for future enlargement) near
maximum section.

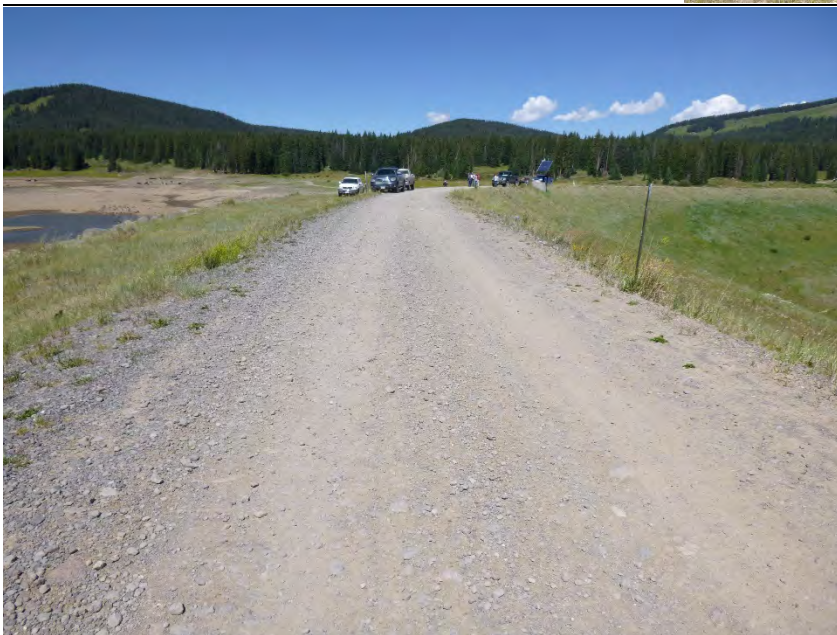
Typical view along dam crest.

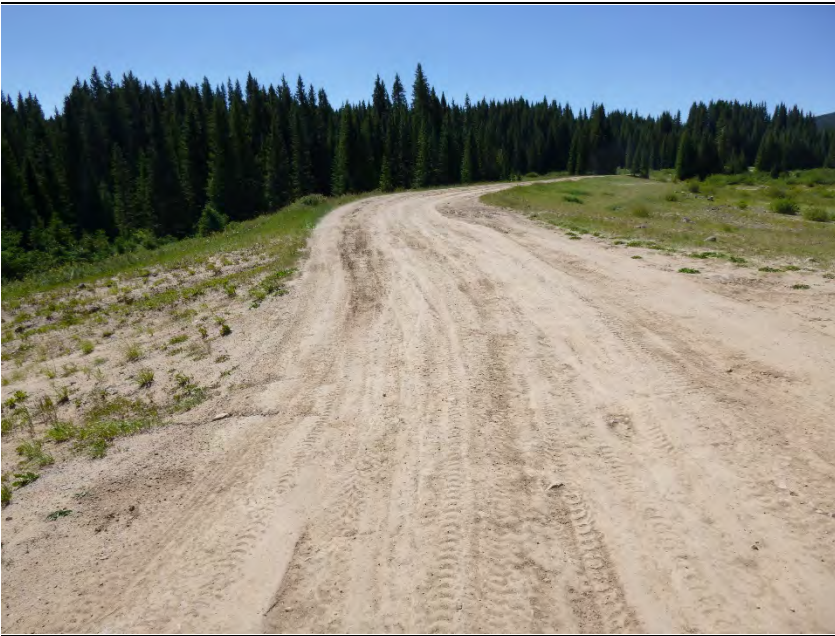
(11) Numerous ruts and puddles along far right end of dam as observed over recent past years. Remainder of crest recently graded with spot treatment of ruts and puddles and appears in Good condition.

Dam crest along far right freeboard dike.

(68a) Repair rut damage and grade right end of Main dam crest.

7/25/2019 - along right end of Main Dam.

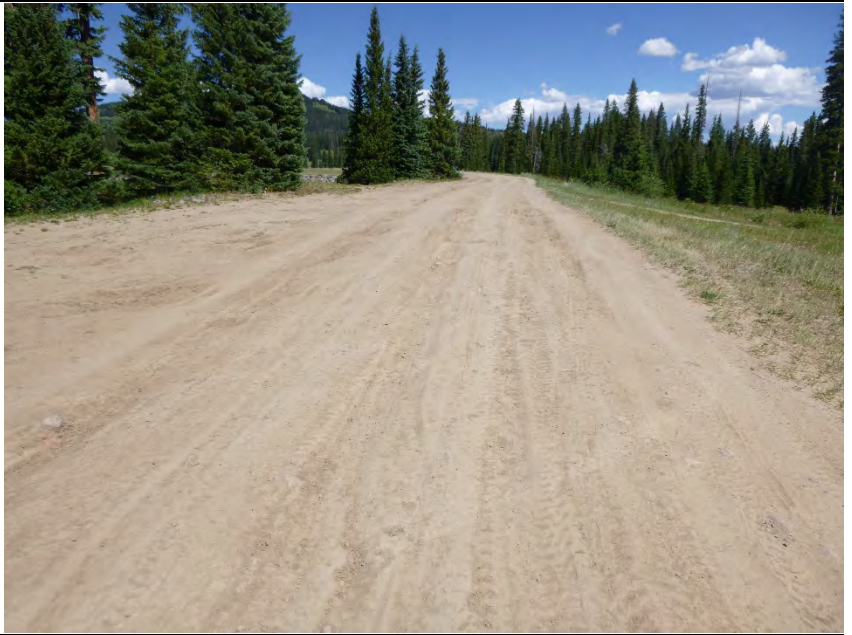
Looking back towards main dam.

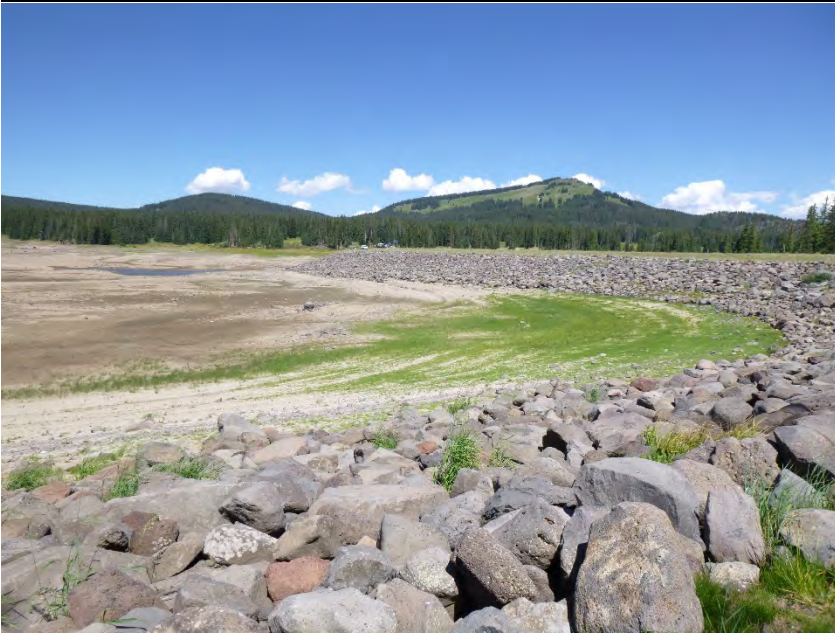
Overall view of upstream slope from far right end of dam.

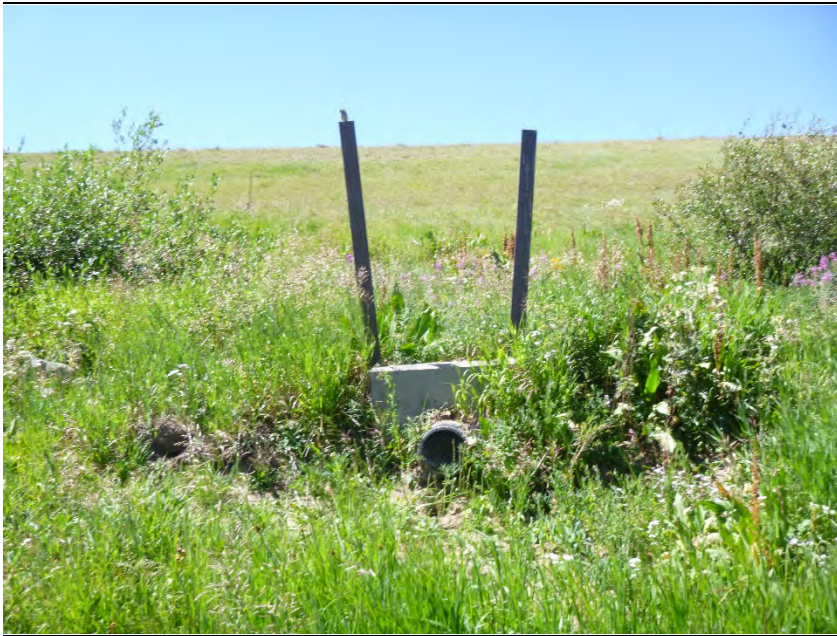
Toe drain outfall (drain 'A').

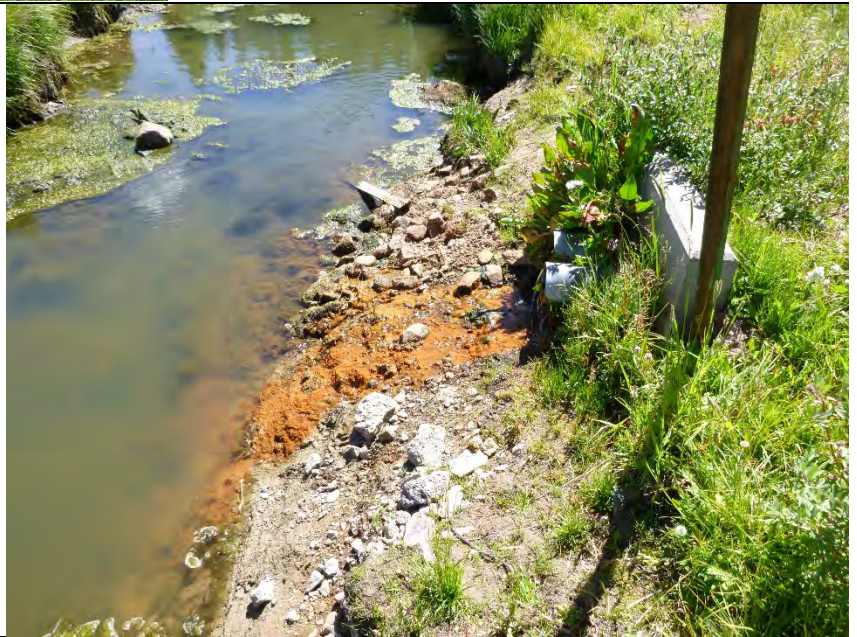
(38) Few drain outfalls becoming partially obstructed with moss and debris buildup.

Toe drain outfalls.

8/6/2020 - Clean moss and debris from drain outfalls.

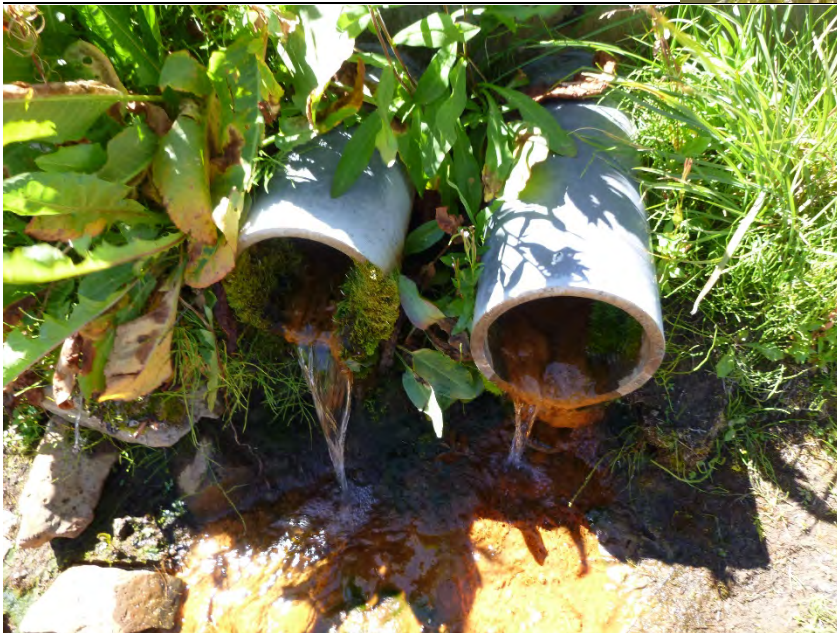
Toe drains B-1, B-2, and drains through the downstream outlet wingwalls producing trickle flows during inspection. Otherwise, no seepage observed during inspection with empty reservoir.

Close-up of toe drain outfalls ('B-1' right in photo, and 'B-2' left in photo).

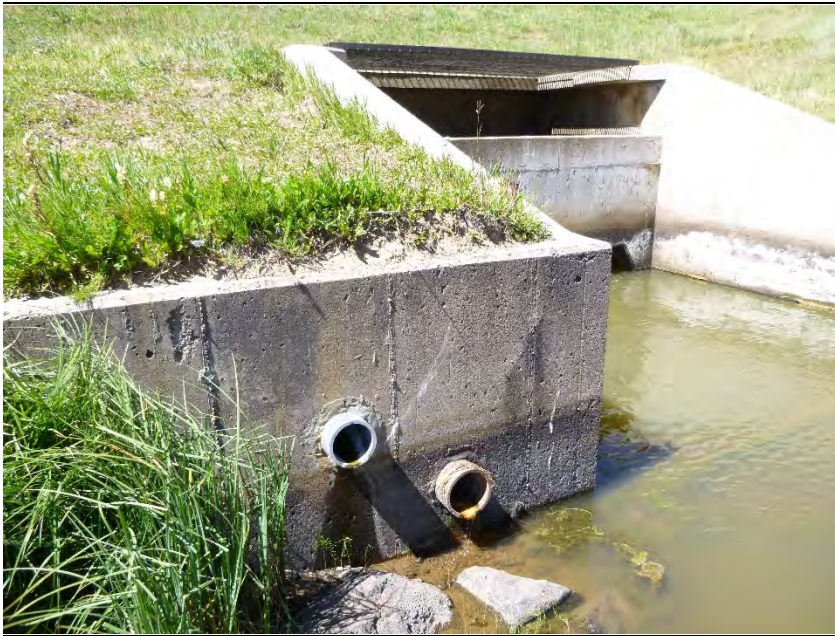
Outlet Chamber Drain (left in photo) and Conduit Filter Drain (right in photo) from right wingwall of downstream outlet structure.

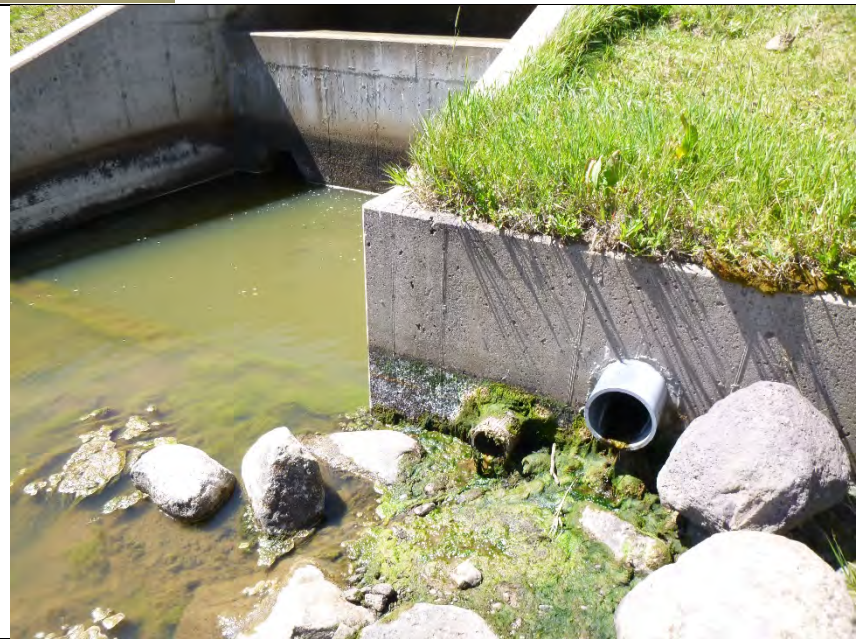
Toe drain (right in photo) and Conduit Filter Drain (left in photo) from left wingwall of downstream outlet structure.

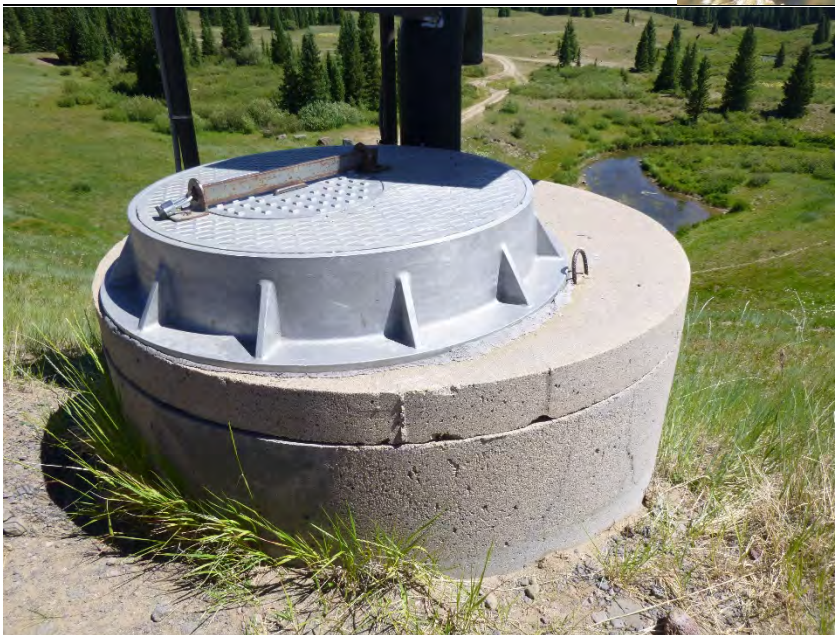
Outlet valve control vault.

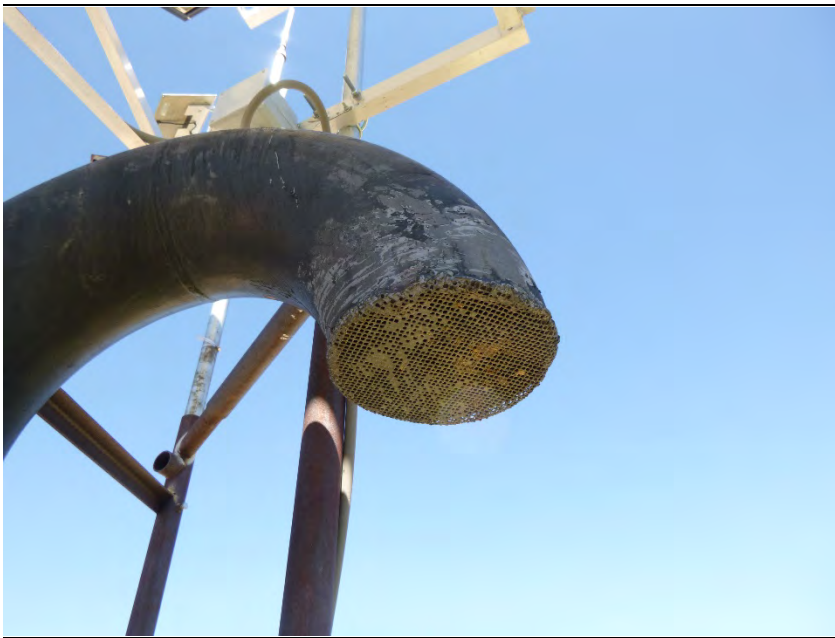
Air vent.

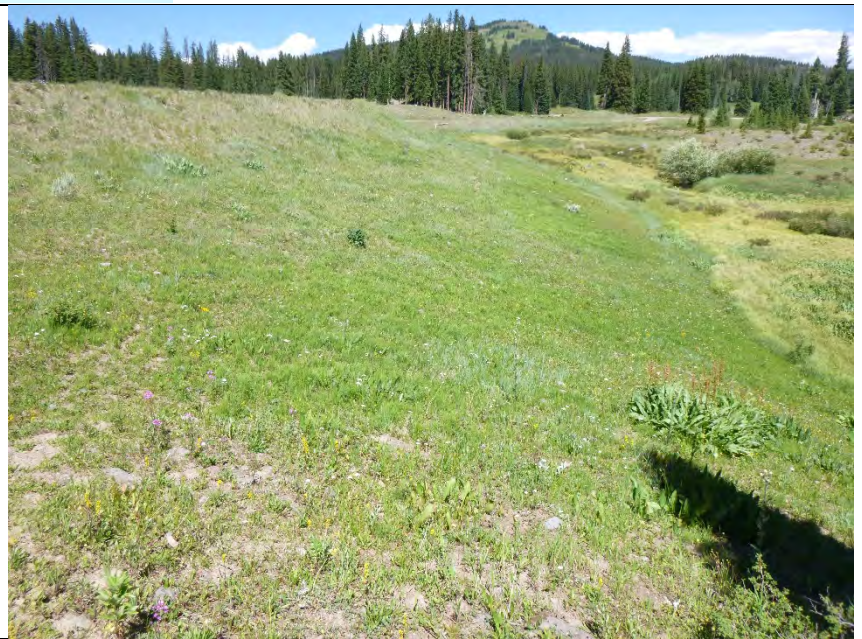
Typical view along downstream slope.

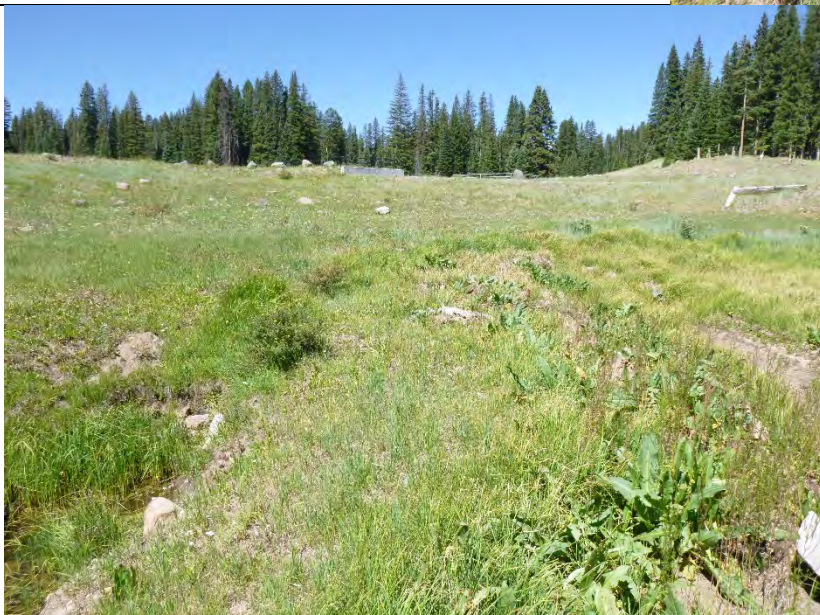
Stilling basin drain outfall channels (downstream end of drains obscured by grass in photo)

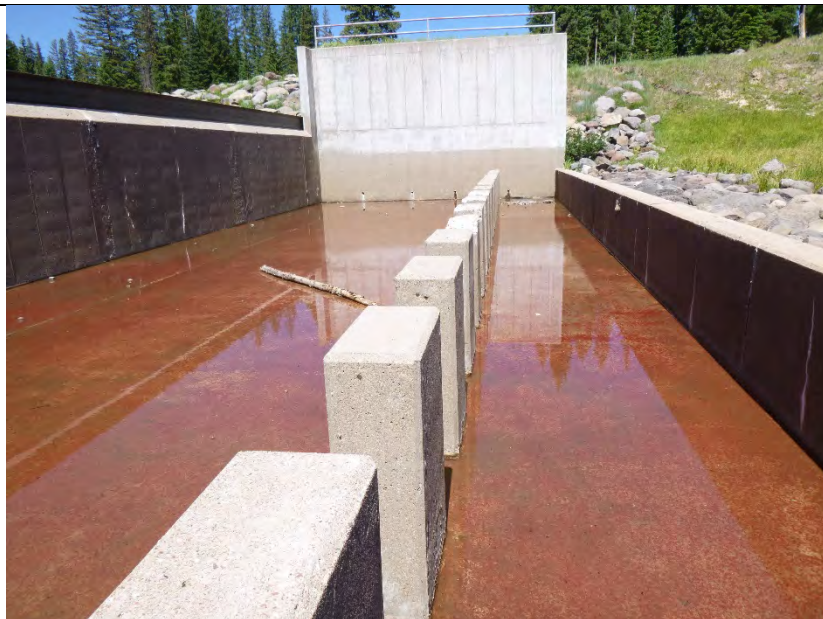
Spillway stilling basin.

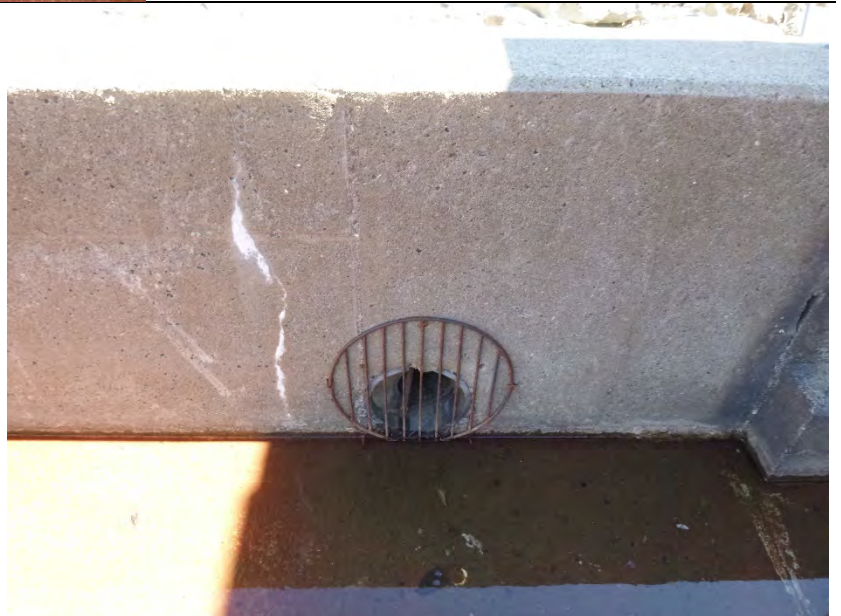
Stilling basin drain cleaned since last inspection. Only 2-3" of standing water in stilling basin remains.

Stilling basin drain.

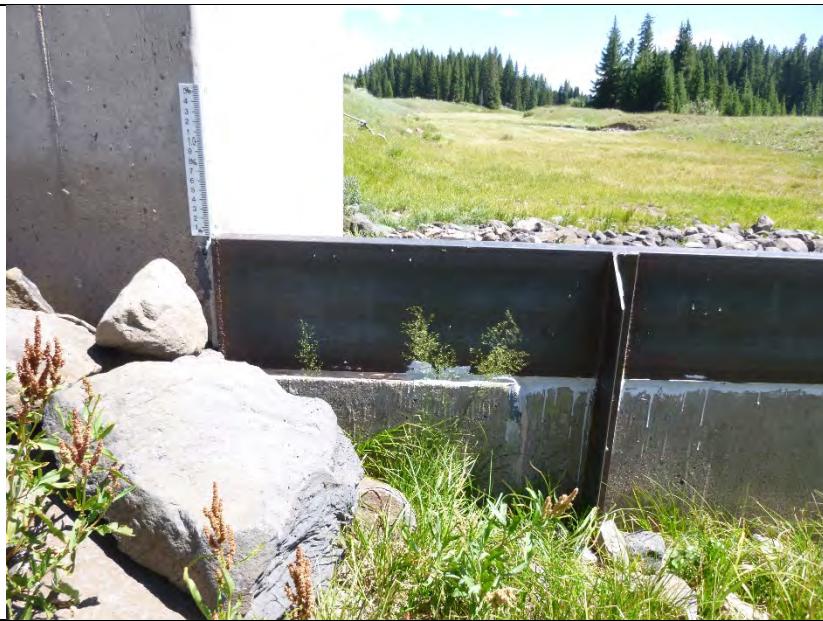
Original concrete sharp crested weir with steel stoplog constructed around 1991.

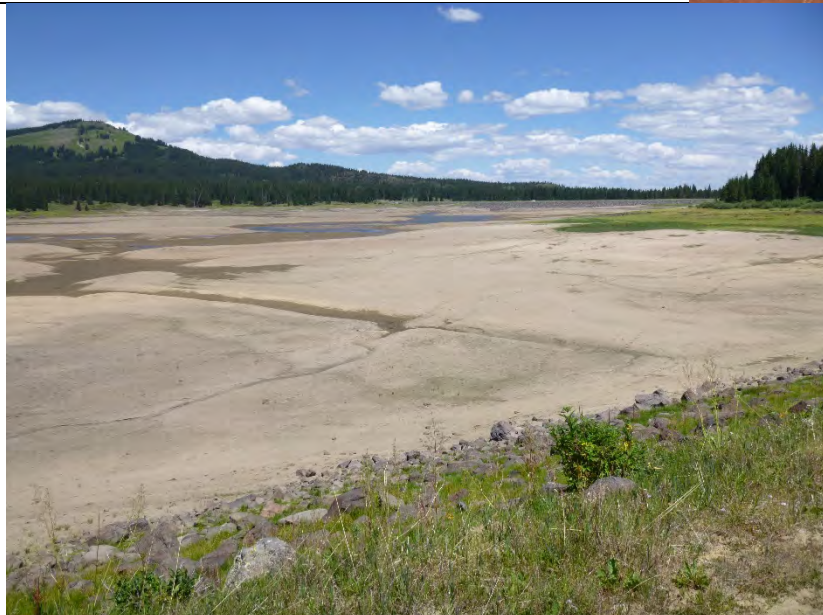
View of empty reservoir from crest of Auxiliary dam located on southwest end of reservoir.
